# ICOMOS Methodology for Building Assessment and Mitigation following the January 12, 2010 Haiti Earthquake

11 April 2010

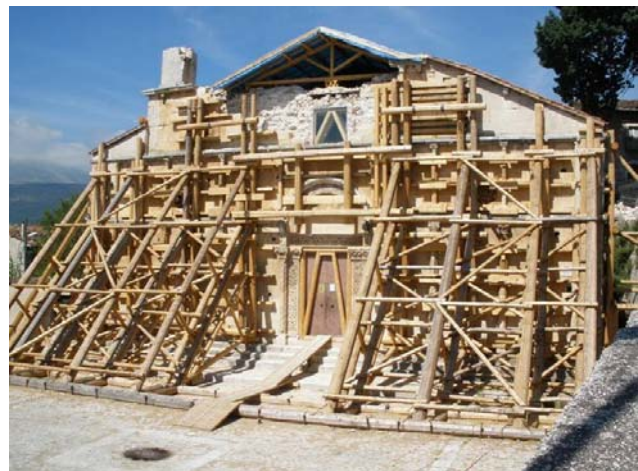
Shoring of the façade of Santa Giusta church in Bazzano from “Protection of the cultural heritage in the post-earthquake emergency” by C. Modena and L. Binda.

**Shoring** consists of numerous timber or steel members leaning diagonally against a vertical wall to counteract the overturning action. It is relatively easy to assemble and typically does not require lifting equipment. The following disadvantages are noted:

- Requires considerable quantities of timber, steel, or other shoring materials
- Depending on the complexity, shoring may require a significant amount of time for assembly
- Can hinder circulation around the street and building
- Can constitute additional mass against the building which can be dynamically activated by aftershock tremors

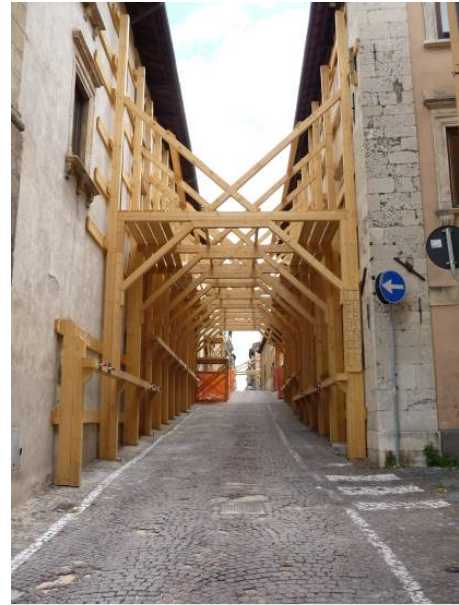
Example of the contrast system used in L'Aquila from "Protection of the cultural heritage in the post-earthquake emergency" by C. Modena and L. Binda.

**Contrast system** is a type of shoring that consists of bracing one building against another using timber. This offers similar advantages to shoring with less materials but must be engineered to ensure proper load distribution and path. It may also be designed to provide better circulation around the building as compared to shoring.

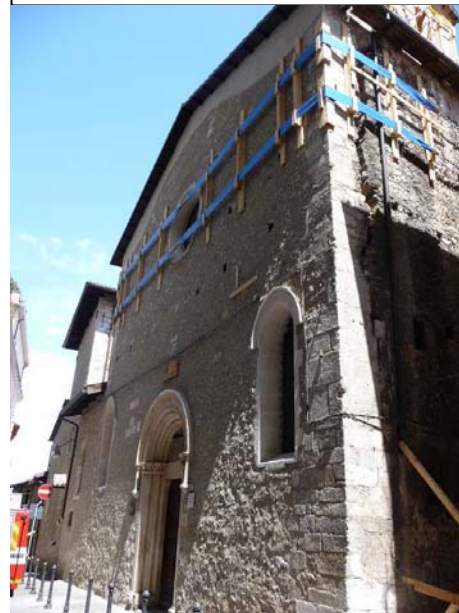
Example of the polyester strapping system on L'Aquila from "Protection of the cultural heritage in the post-earthquake emergency" by C. Modena and L. Binda.

**The strapping (or belting) system** acts as a corset to prevent the damaged walls from collapsing outward. Straps used have traditionally been steel cables. In the recent L'Aquila earthquake polyester straps were used and are the same as those used in ports to handle heavy packages. The use of the ratchet allows for securing the strap at the
