Disaster Risk Management for the Historic City of Patan, Nepal

Final Report of the Kathmandu Research Project

**Research Center for Disaster Mitigation of Urban Cultural Heritage,
Ritsumeikan University, Kyoto, Japan**

Institute of Engineering, Tribhuvan University, Kathmandu, Nepal

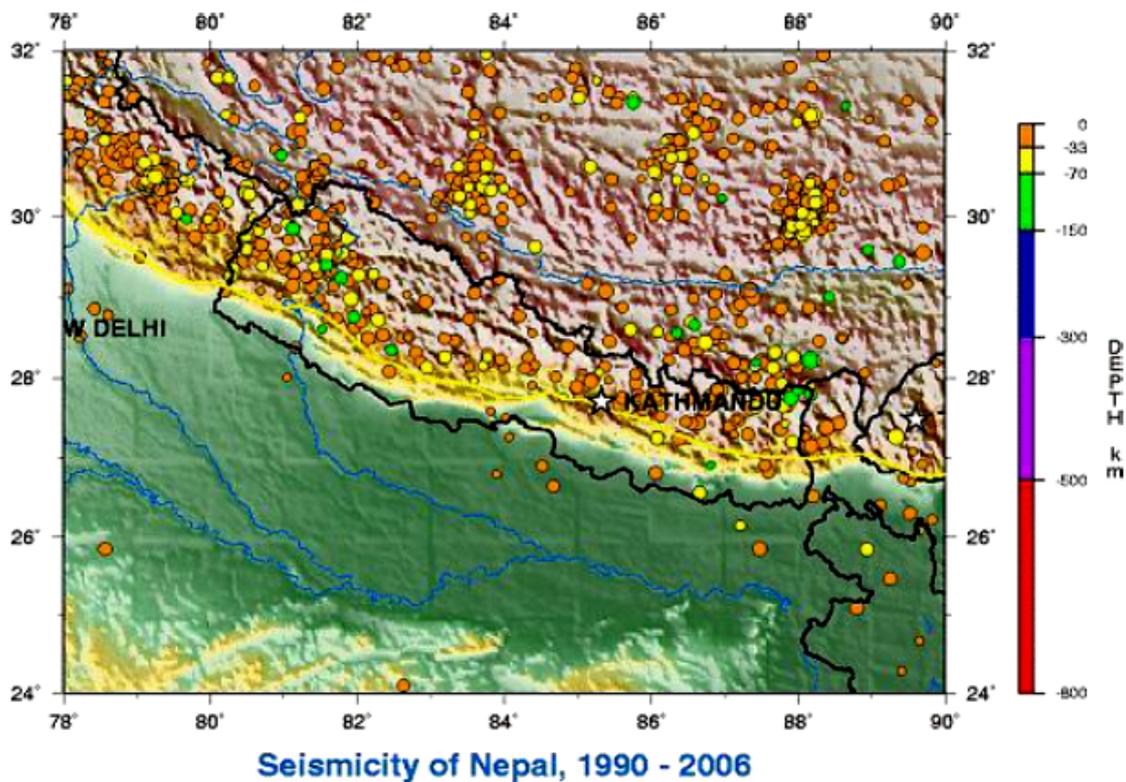
Fig.1.3: Seismicity map of Nepal. Source: 1). *Note:* Each circle represents a recorded earthquake. Most of Nepal's earthquakes are relatively shallow (≤ 33 Km depth) and located near the estimated boundary between the India - Eurasian Plates.

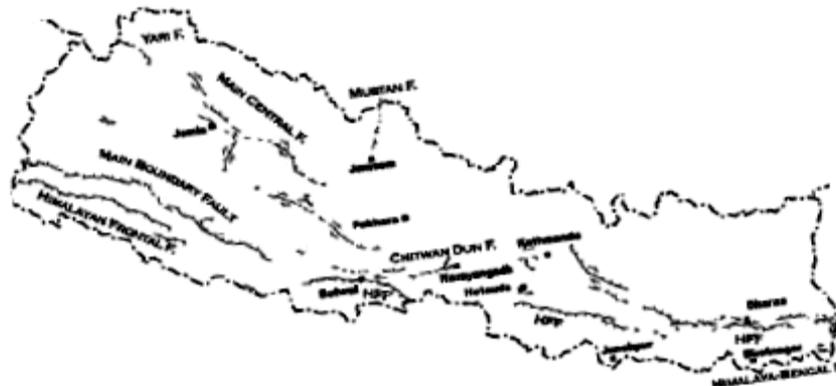
Fig. 1.4 Active fault distribution in Nepal (Source: 5)

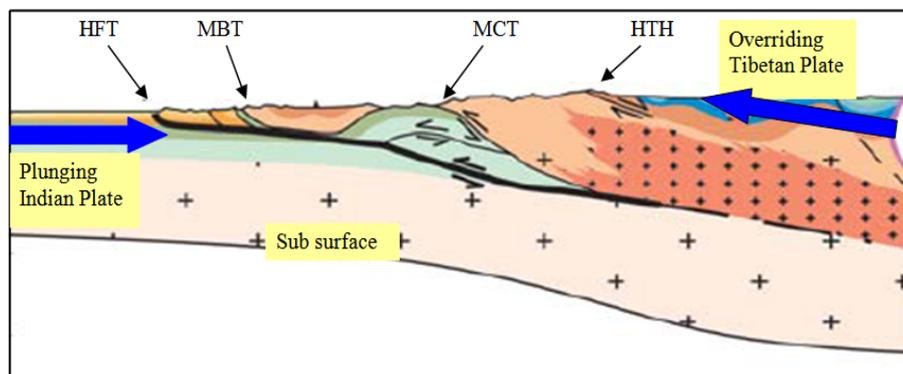
Fig. 2.1b North-South cross section of Nepal showing depth and faulting systems. Source: 2)

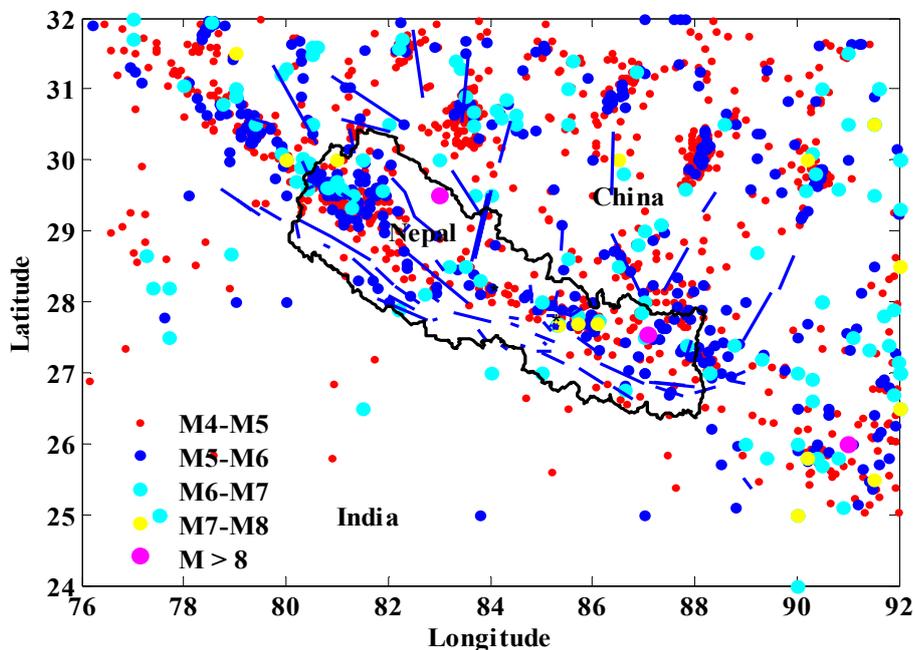
Fig. 2.2 Historical earthquakes (points) and faults (line)

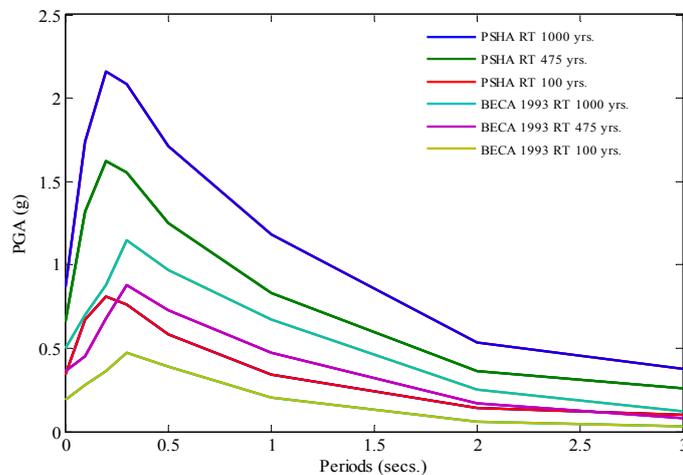
Fig. 2.5 Comparison of spectra for Kathmandu.

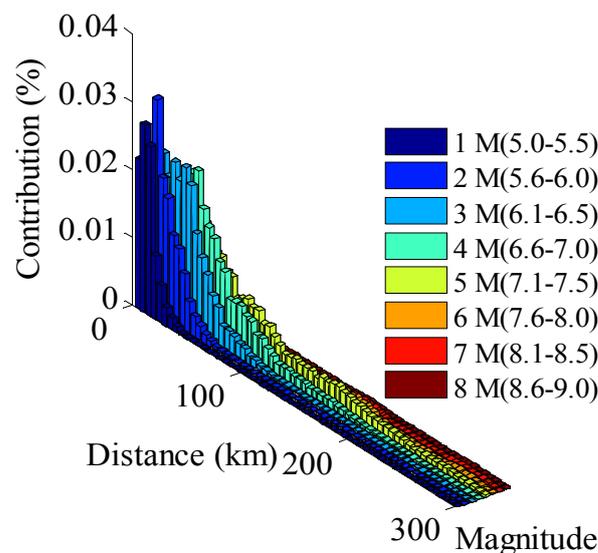
Fig. 2.6 Deaggregation of hazard for peak ground acceleration 10% probability of exceedences in 50 years

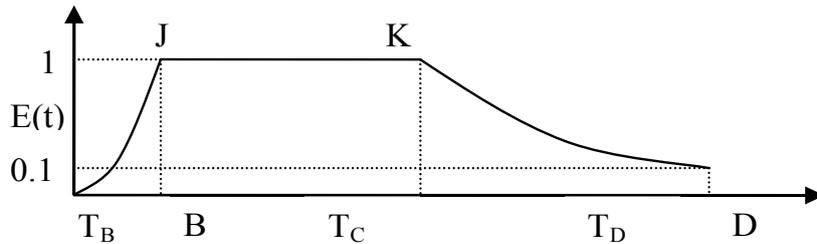
Fig. 2.7 Envelope function

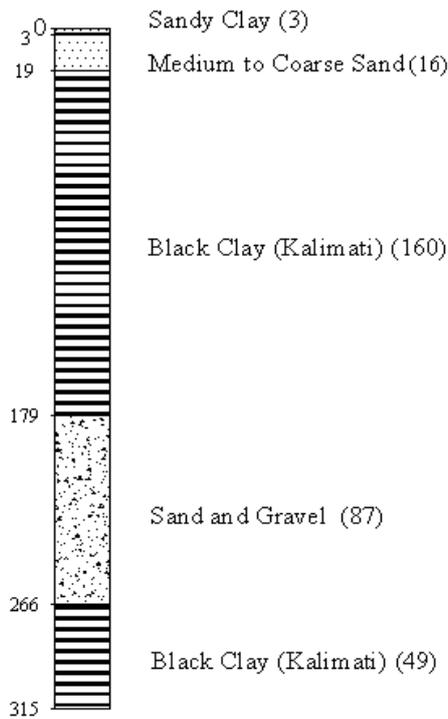
Fig. 2.15 Interpolated Borehole log at the Site

The shear wave velocity for each sub-layer is estimated using relations described in (1) above, and density is assigned to those sub-layers as described in (2). The properties of the soil sub layers including the shear wave values and the densities, along with the simulated seismic ground motion at the bedrock are used to carry out the ground response analysis. The shear modulus reduction curves and damping curves used for different soil types are shown in Fig. 2.16. The water table level in the analysis is taken as 3m from surface, which is the value found for the construction site in the vicinity. The Linear as well as Equivalent linear site response analysis are carried out in SHAKE 2000 using simulated earthquake motion for the bedrock of the same location taken as input motion shown in Fig. 2.17. The Fourier amplitude spectrum of the simulated ground motion acceleration time history at the bedrock is shown in Fig. 2.18. The ground motion acceleration time histories, Fourier amplitude spectra, and response spectra for each site response analysis are computed at the surface of the site.

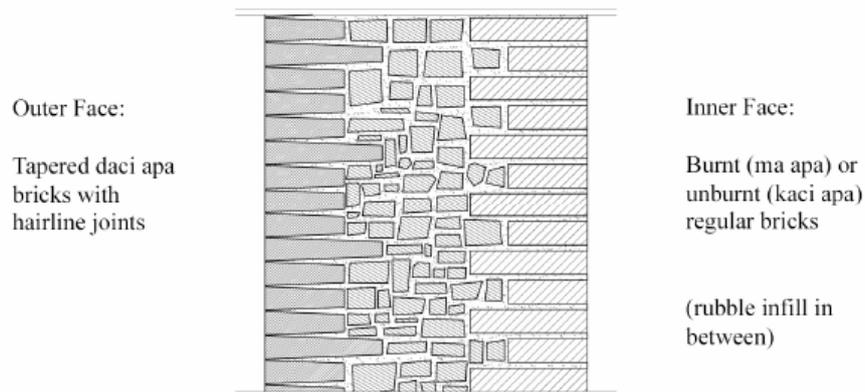
The inner face of the wall is made of one wythe of burnt or even unburnt brickwork (*kaci apa*). Only rarely do those thick walls consist of continuous solid brickwork. More often they consist of a core of brick rubble infill set between an outer faces of brick (Fig.3-1.1). The bricks are traditionally laid in mud mortar. Commonly, all bricks of the outer face are laid as runners, so that there is no or only little bonding between the different leafs. Cross walls are often simply butt jointed with no interlocking at all. Figs. 3-1.2a and 3-1.2b presents the walls made of ordinary clay brick and walls made with the conical bricks, *daci apa*.

Fig. 3-1.1 Typical wall cross section

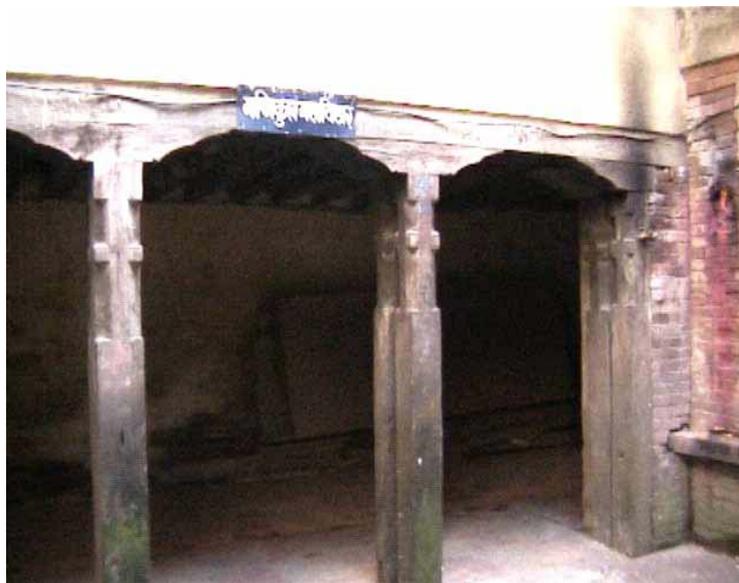
The *dalan* is one of the prominent features of many traditional buildings in the locality. It is normally a ground floor space with a timber frame made of twin columns, surmounted by a capital on which sits a double beam (Fig. 3-1.3). The two adjacent timber frames are usually connected only at the level of the beam. This space is most commonly found at the ground floor of the main façade of buildings in which the front room is used as shop or workshop.

Fig. 3-1.3 *dalan* structure at ground floor of a courtyard

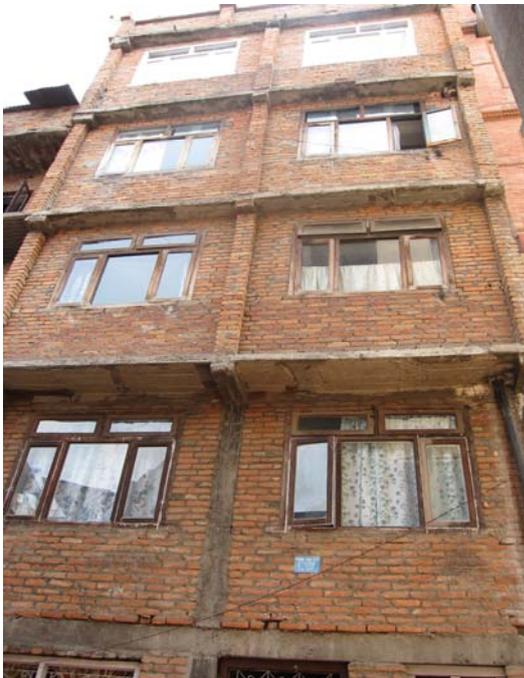
Fig. 3.7 Reinforced concrete frame building with unclear load path, Jhatapol study area.

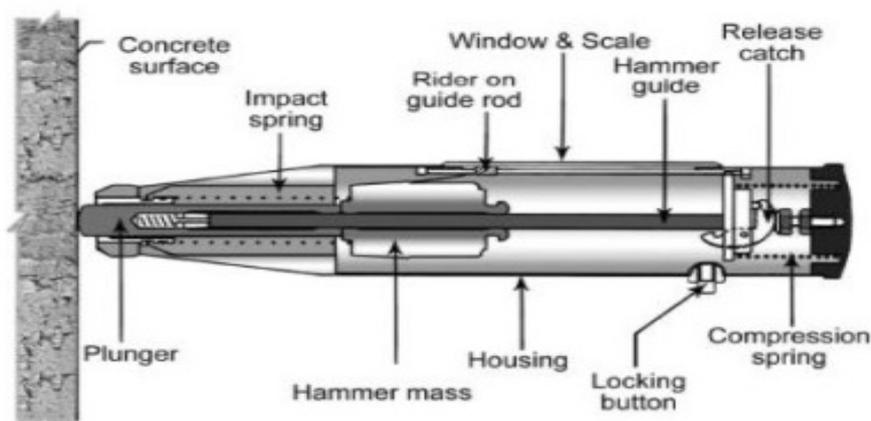
Schmidt Rebound Concrete Hammer test is carried out to assess the concrete and strength characteristics. It is a non-destructive test in which concrete can be tested in situ condition. This instrument enables engineers to control concrete quality and to detect weak spot. As the test can be done in the site condition, the strength of concrete can be evaluated in different time interval. The main advantage of this test is that it is easy to handle and it saves time. A typical Schmidt rebound Hammer is shown in Fig. 3-2.9.

Fig. 3-2.9 Typical rebound hammer

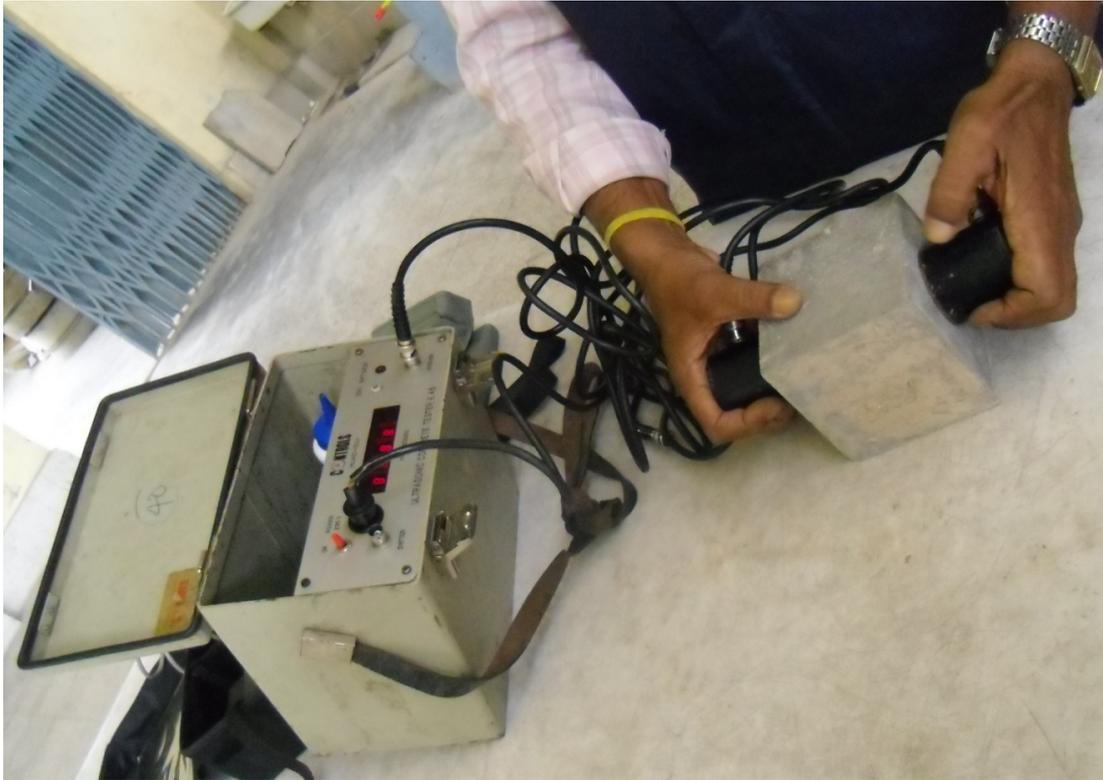
The equipment for the test consists essentially of an electrical pulse generator, a pair of transducers, an amplifier and an electronic timing device for measuring the time interval between the initiation of a pulse generated at the transmitting transducer and its arrival at the receiving transducer (Fig. 3-2.12). Two forms of electronic timing apparatus and display are available, one of which uses a cathode ray tube on which the received pulse is displayed in relation to a suitable time scale, the other uses an interval timer with a direct reading digital display.

Fig. 3-2.12 Ultrasonic pulse velocity test equipment

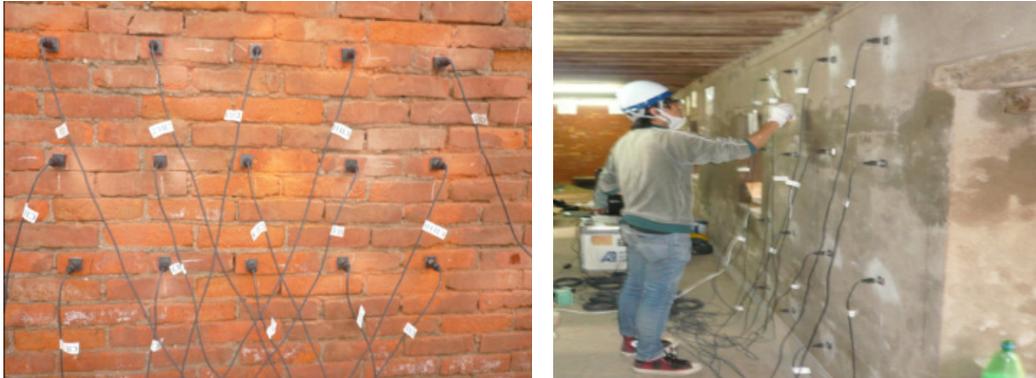
measurements - two on each surface, and the other on cross sections were taken. Sensor arrangements at surfaces and at cross sections are shown in Fig. 3-2.16. Then impact on wall was given by a steel hammer having a small spherical ball at its edge near one sensor and the stress waves obtained at all sensors were recorded. Similarly, impact was given near to each sensor turn by turn and measurements at other sensors were recorded.

Fig. 3-2.16 Arrangement of sensors on two sides of the wall

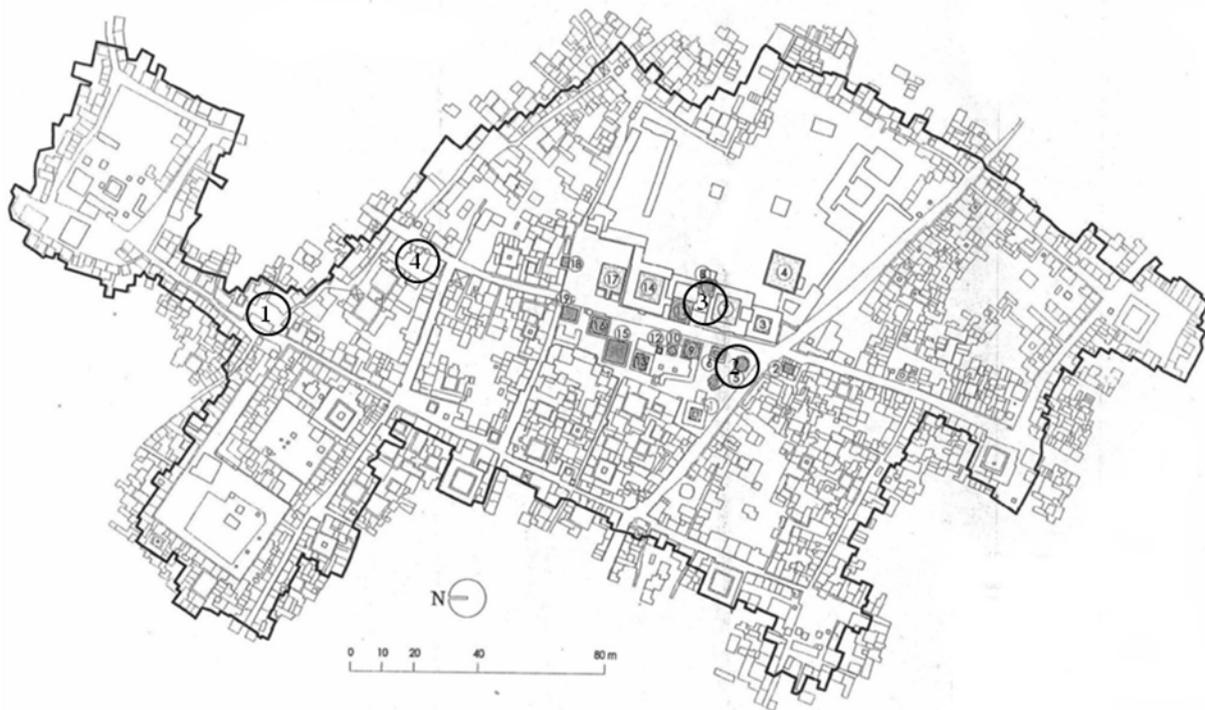
Fig. 3-2.24 Location of seismometers in World heritage site Patan Durbar Square area

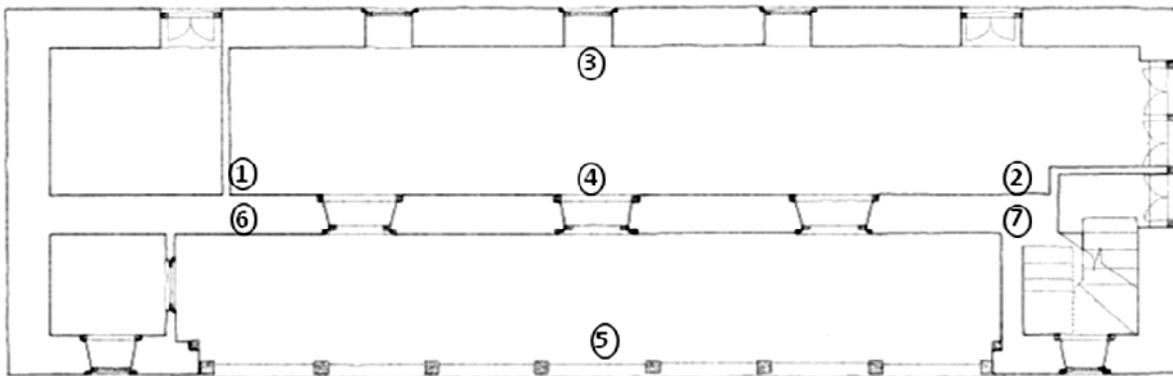
The building has been partitioned into two parts along longitudinal direction. The front side has big opening. Series of micro tremor ambient vibration measurements were taken at various locations of the building in the ground, first and second floors respectively. The measurements were recorded at seven different locations of the building as shown in the plan of the building in Fig. 3-2.30.

Fig. 3-2.30 Plan of the building and location of micro-tremor measurements

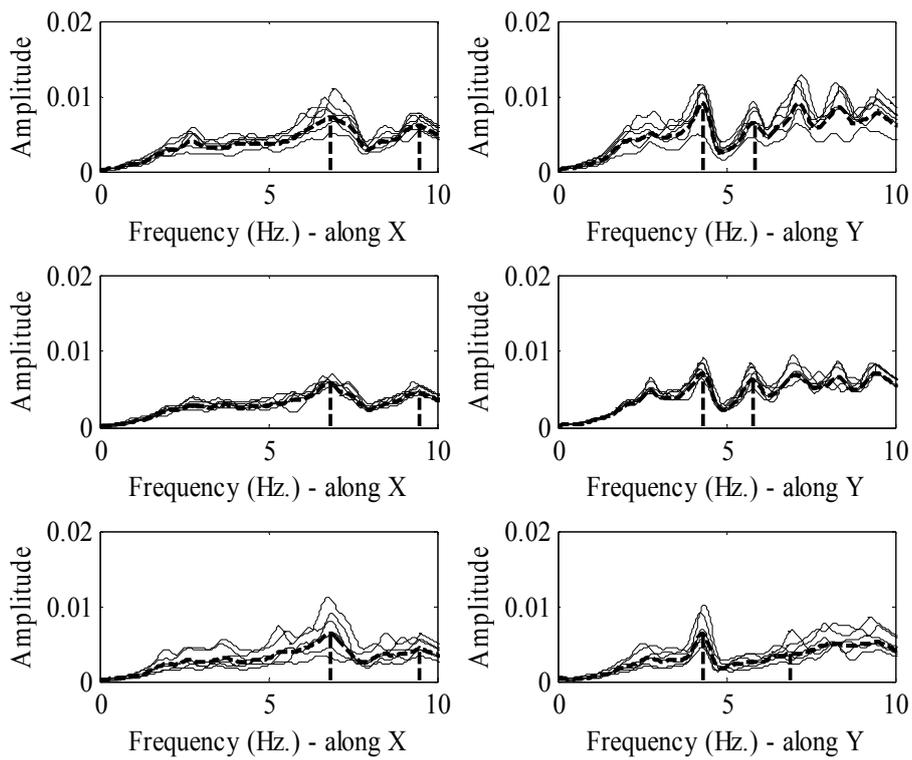
As in the H/V ratio calculation, twelve minutes long records are cut into six segments making 4096 data in each segment to make compatible for FFT excluding the possible noise caused by external factors such as pedestrians and vehicles etc. Fourier spectra of all the records obtained along both longitudinal and transverse directions at various locations of the building were calculated and plotted through Figs. 3-2.31 to 3-2.38 and summarized in Table 3-2.11 for. From the calculation, most dominant natural frequencies are 4.30Hz and 6.52Hz along transverse direction and 6.80Hz and 9.39Hz along longitudinal direction.

Fig. 3-2.31 Fourier spectrums

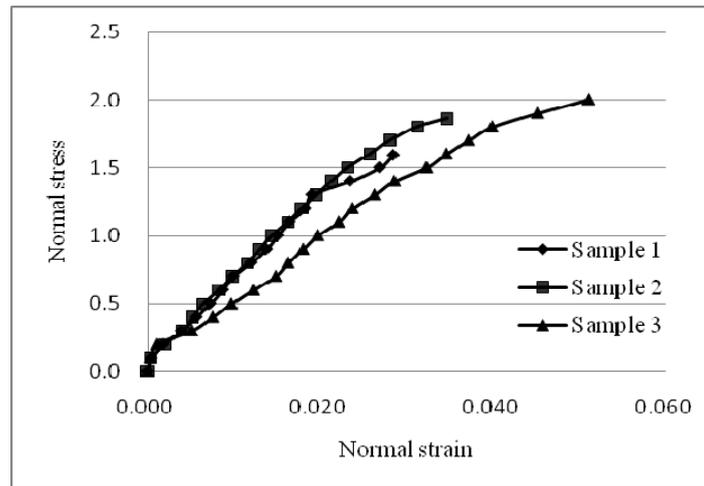
Fig. 3-2.46 Compressive stress and strain relation

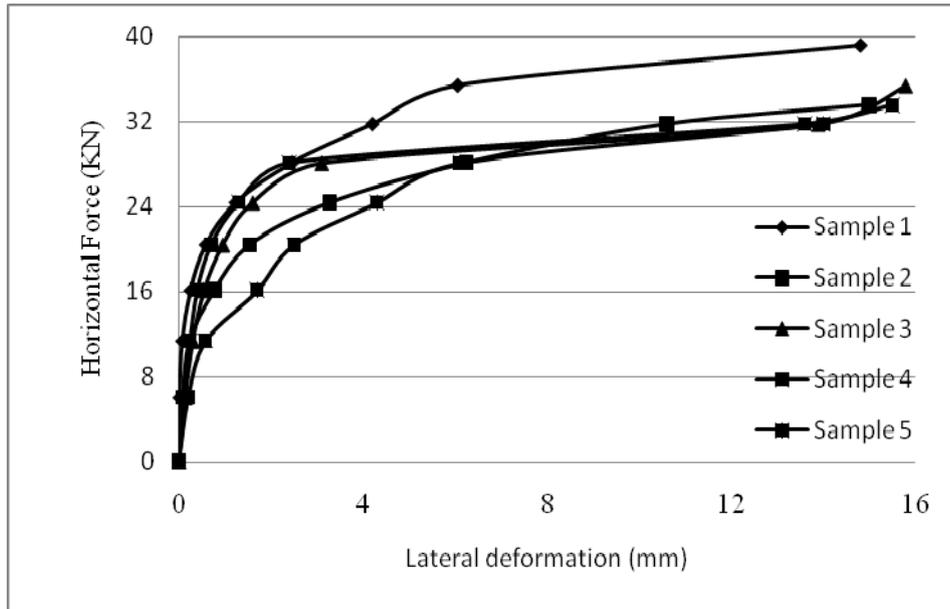
Fig. 3-2.48 Horizontal deformation of wall on 1 ton vertical force

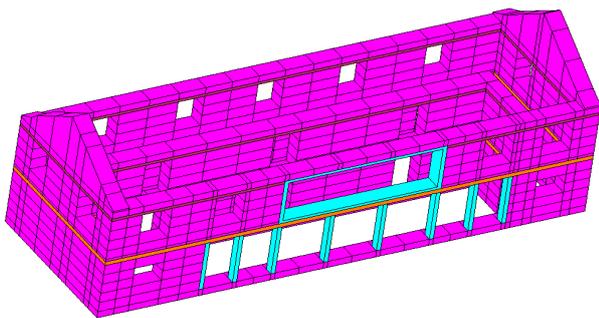
The model building (3-2.50) has been divided into two rooms longitudinally is modeled as shown in the Figs. 3-3.52-3-2.53. It is a double storeyed building; 16.5 m long and 5.6 m wide. The wall is made of traditional brick and 60cm thick at the bottom and 50 cm at the top, a slight tapering from bottom to top. An average thickness 55cm is taken for an analysis. It was constructed three hundred years ago. It sustained damages in earthquakes and repaired many times. Recently, its original roof has been replaced by corrugated galvanized iron sheet which rests over wooden planks and battens and the interior wall has been plastered by cement sand mortar. The floor has been recently replaced by concrete which rests over wooden boards supported by planks and beams. Now, it is repaired hiding its original construction and has been using as public purpose. The building has very large opening in the front side. Wooden posts are supporting the wall of upper storey. In the upper storey, there is a big wooden window placed at mid span of the wall and is slightly projected to outside showing a nice aesthetic view.

Fig. 3-2.52 Simplified FEM model

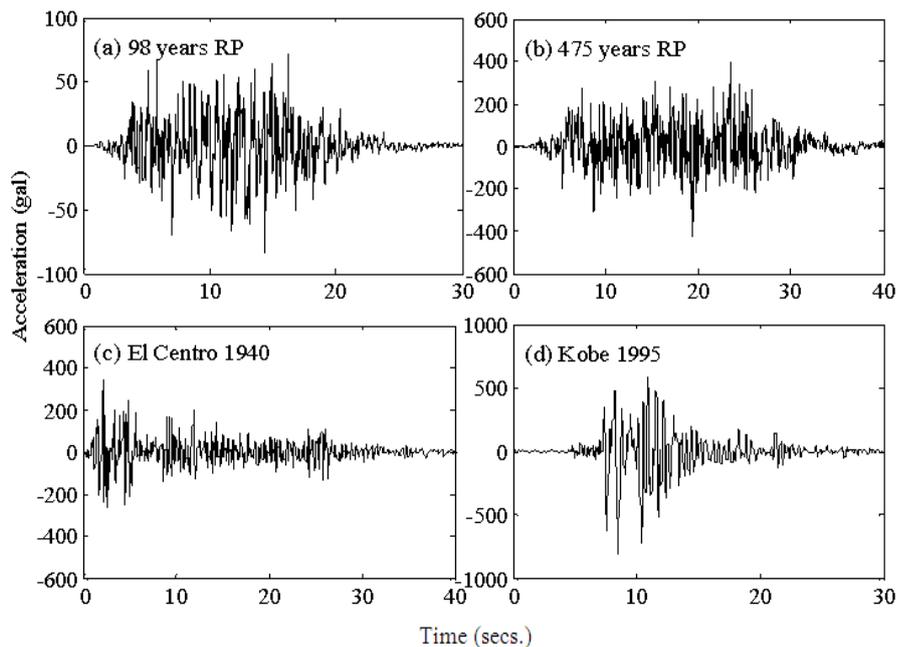
At first, static analysis was run for vertical loads and self weights. And obtained stresses were used in dynamic analysis as initial stresses. In the second step, dynamic analyses were run with an input of Kobe1995 earthquake, El Centro 1940 earthquake, simulated for 98 years and 475 years return period (Fig. 3-2.54). Equations of motions were evaluated at 0.01 interval of time by Newmark's beta method satisfying the Mohr-Coulomb criterion for slide and separation 3). The residual forces obtained from deducting actual force developed and permissible force calculated from constitutive relationship produces non linear deformation at the joints which are evaluated by Newton Raphson method.

Fig. 3-2.54 Input ground motions

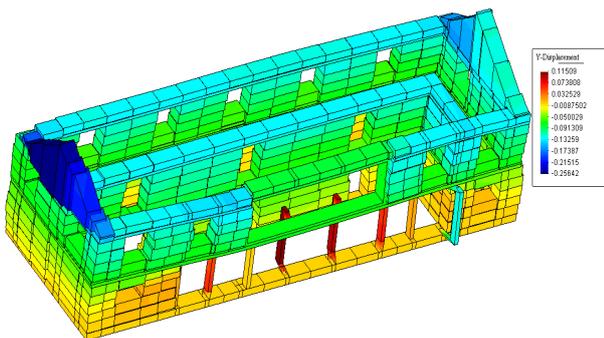
Dislocation of vertical posts and initiation of deformations also can be seen in the simulated 98 years earthquake, however, the values are very small (Fig. 3-2.59). This shows that the building is able to resist the around 100 gal or less amplitude earthquakes, but, it cannot resist even greater than 150 gals acceleration since it has sustained large deformation in 50% reduced El Centro earthquakes (Fig. 3-2.58). However, duration and frequency content should also be considered while defining complete failure. As reported in contemporary literatures, El Centro 1940 earthquake is the first recorded earthquake and 40% houses had been damaged. It is quite reasonable to say that this brick masonry house sustain very large cracks and deformations and cannot survive. The building sustains very large deformations under all given earthquakes and it is proved to be very weak and cannot take any kind of severe earthquake loadings.

Fig. 3-2.55 Deformations in 475 years RP earthquake

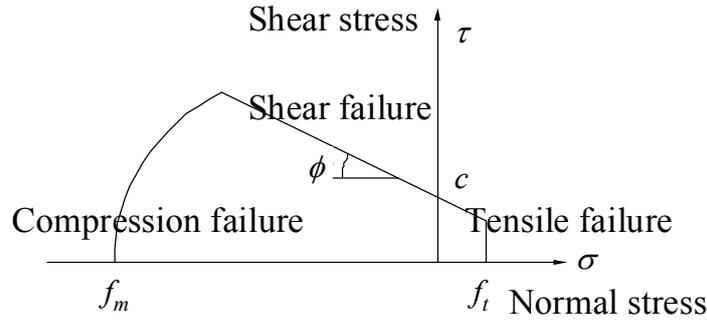
Fig. 3 Modeling of failure phenomena

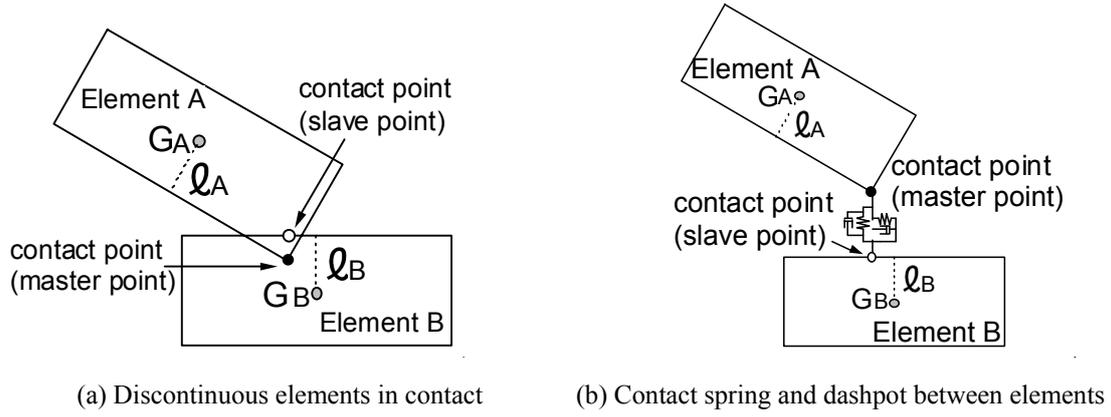
Fig. 4 Modeling of the contact spring and dashpot between elements

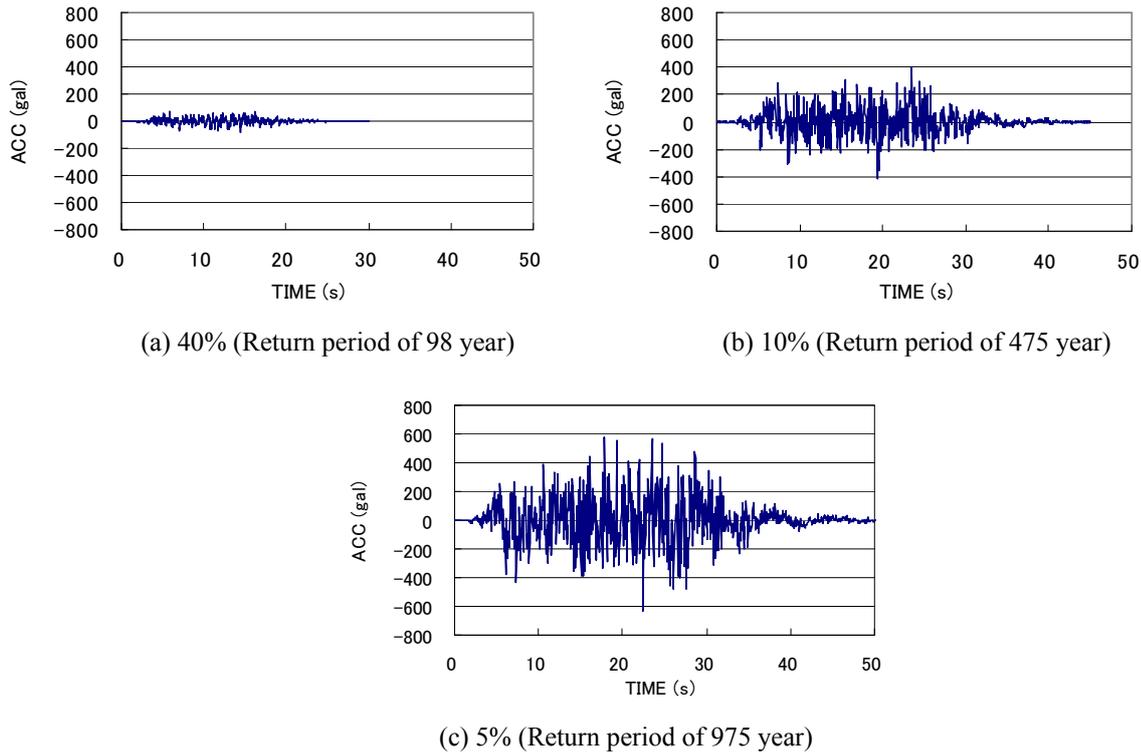
Fig. 11 Input ground acceleration with respective occurrence probability in 50 years

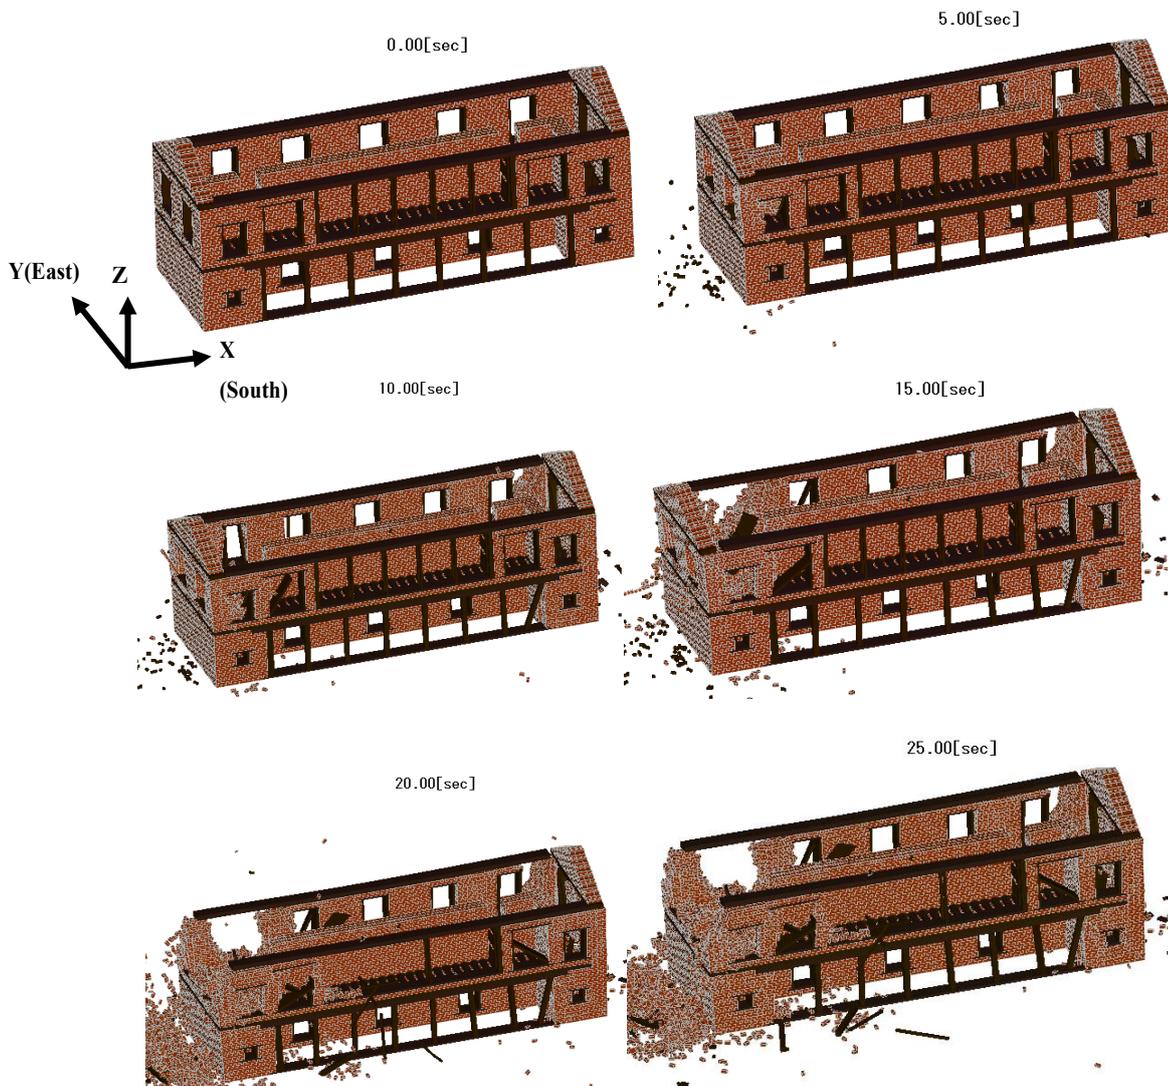
Fig.12 Seismic behavior of Case 1X (input ground motion : X direction, occurrence probability in 50 years : 40%)

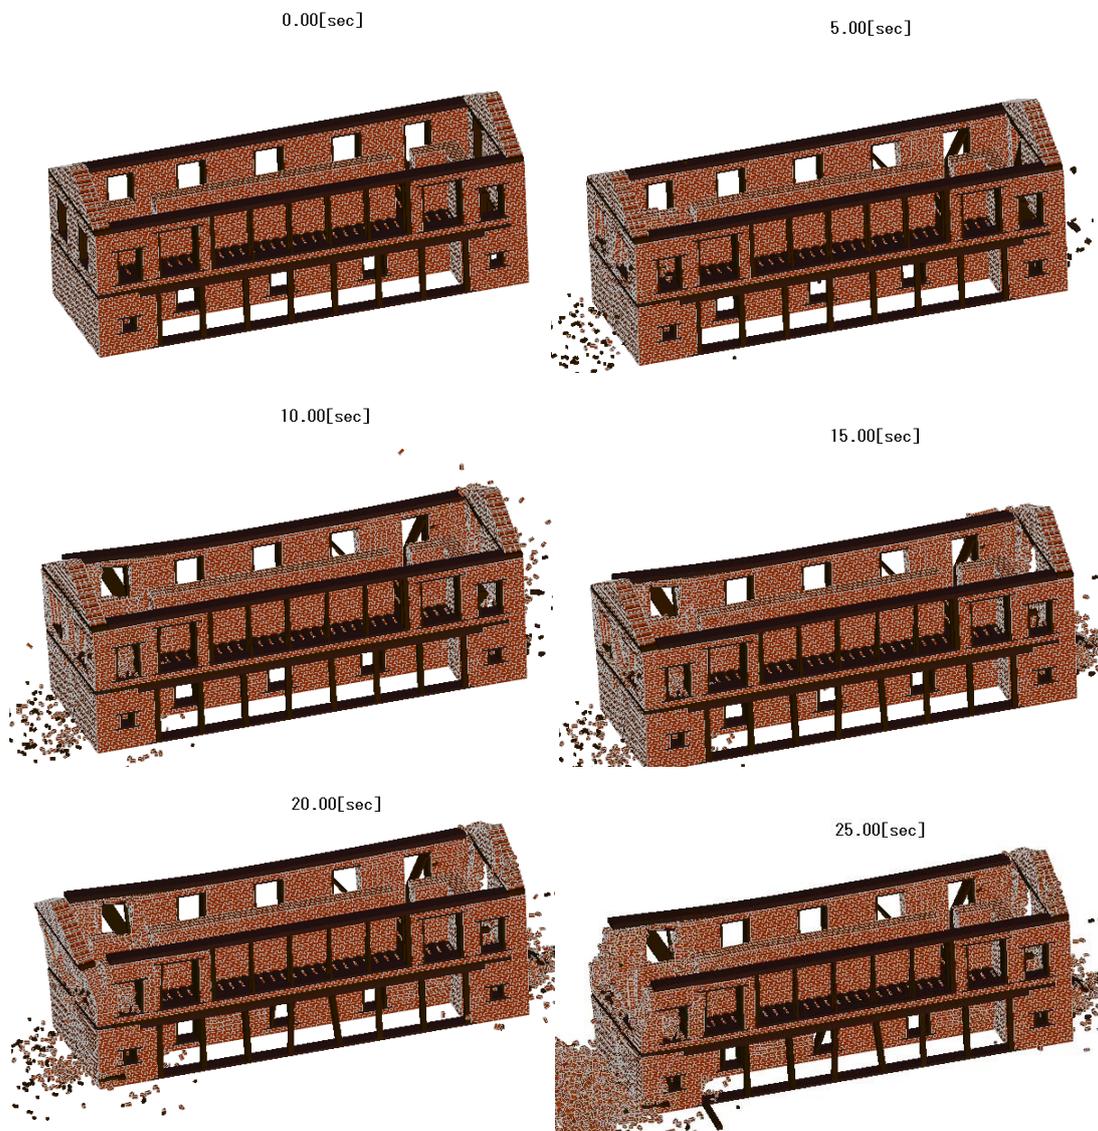
Fig.13 Seismic behavior of Case 1Y(input ground motion : Y direction, occurrence probability in 50 years : 40%)

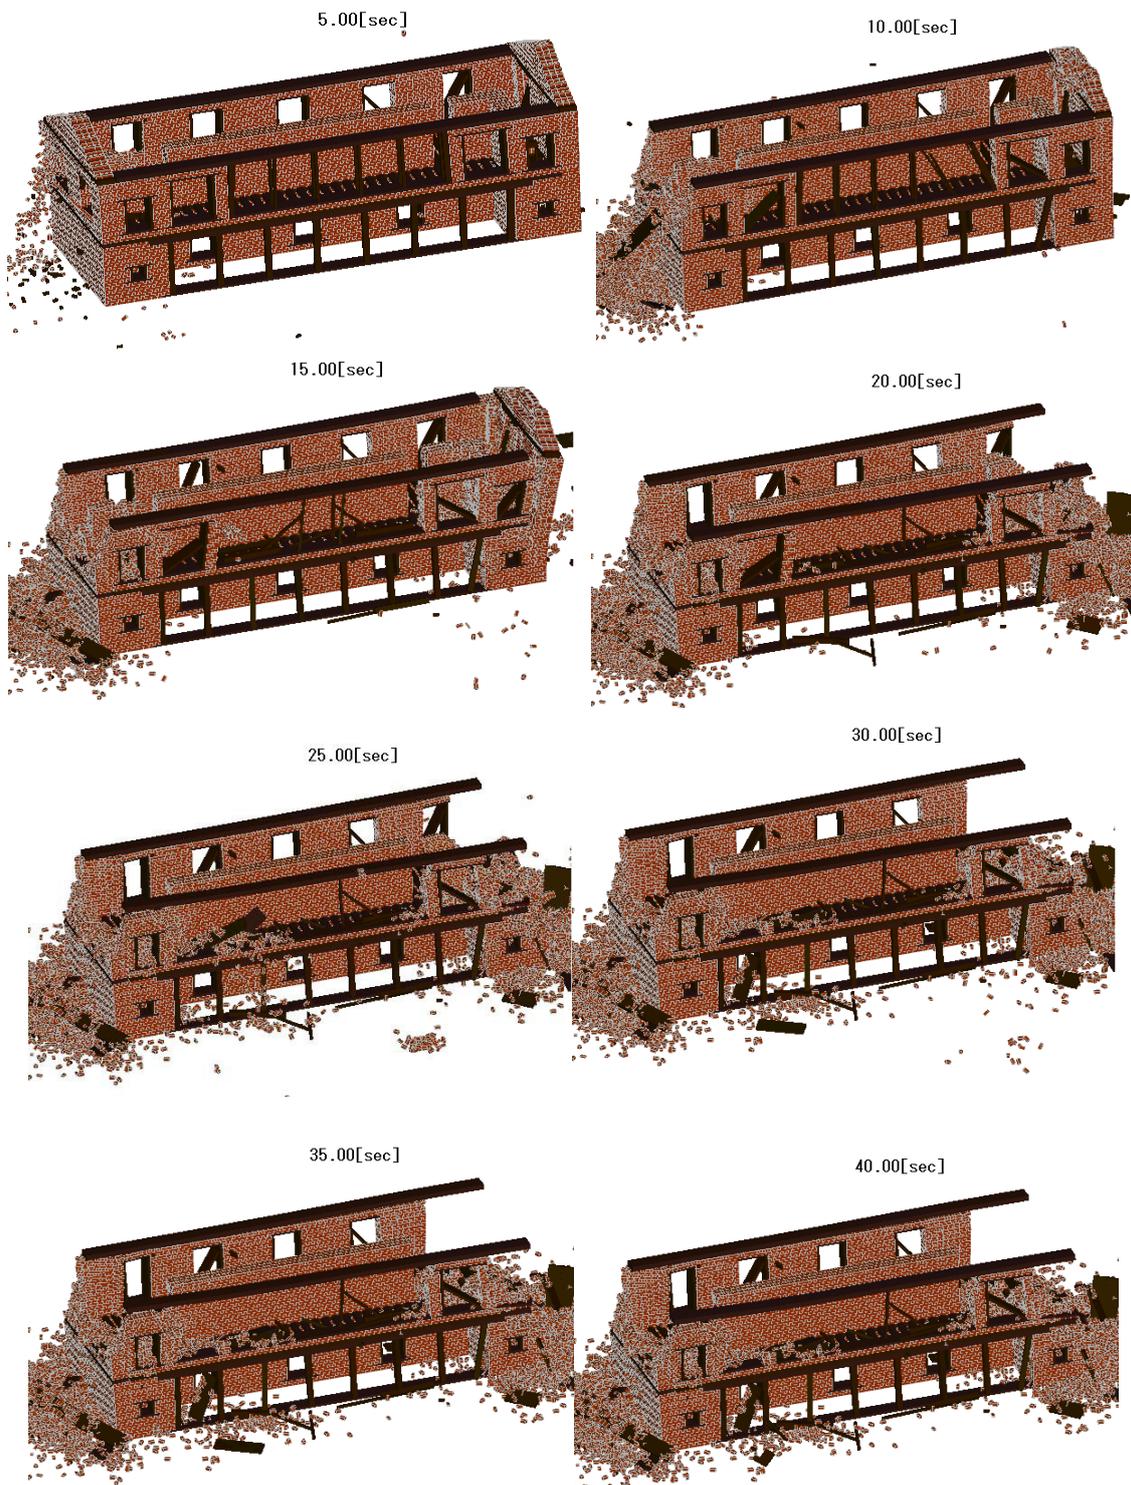
Fig.14 Seismic behavior of Case 2X(input ground motion : X direction, occurrence probability in 50 years : 10%)

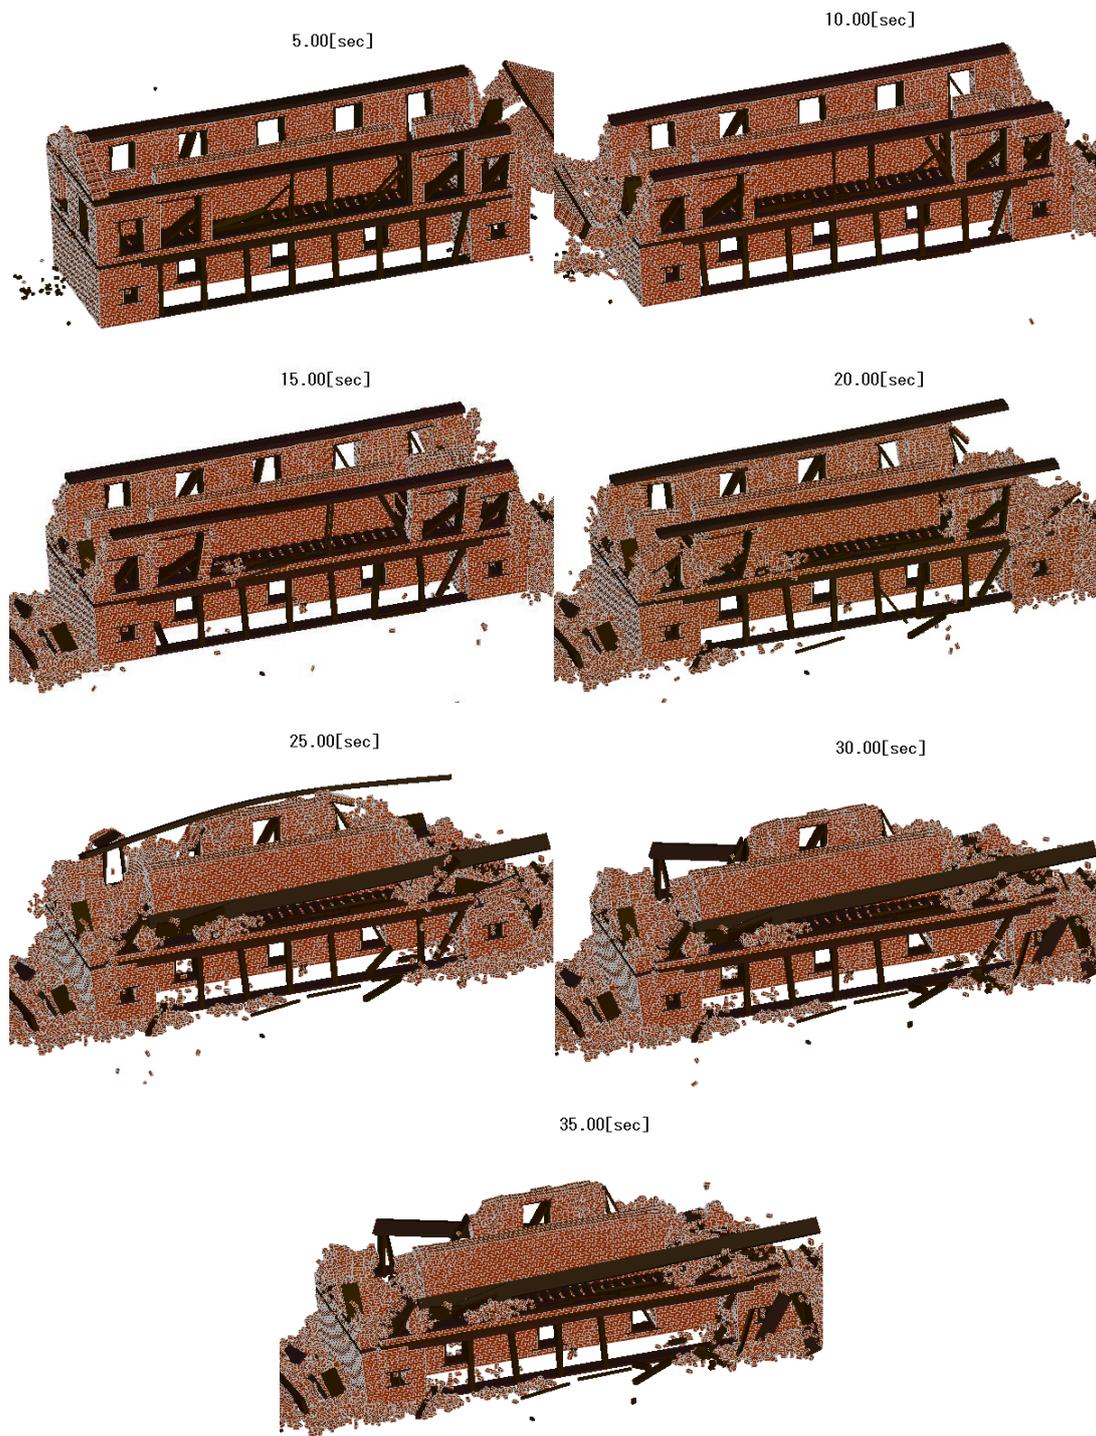
Fig.16 Seismic behavior of Case 3X
(input ground motion : X direction, occurrence probability in 50 years : 5%)

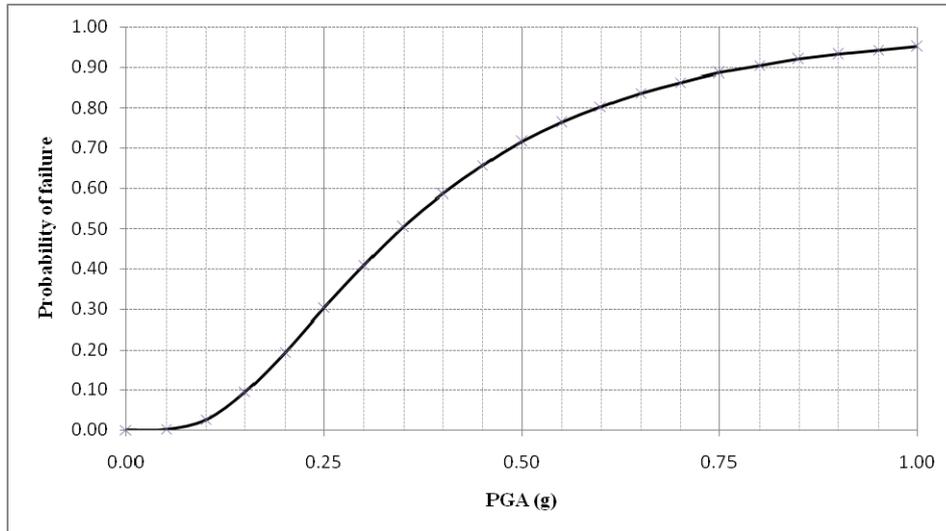
Fig. 3-3.11 Fragility curves for building A7 (CB1)

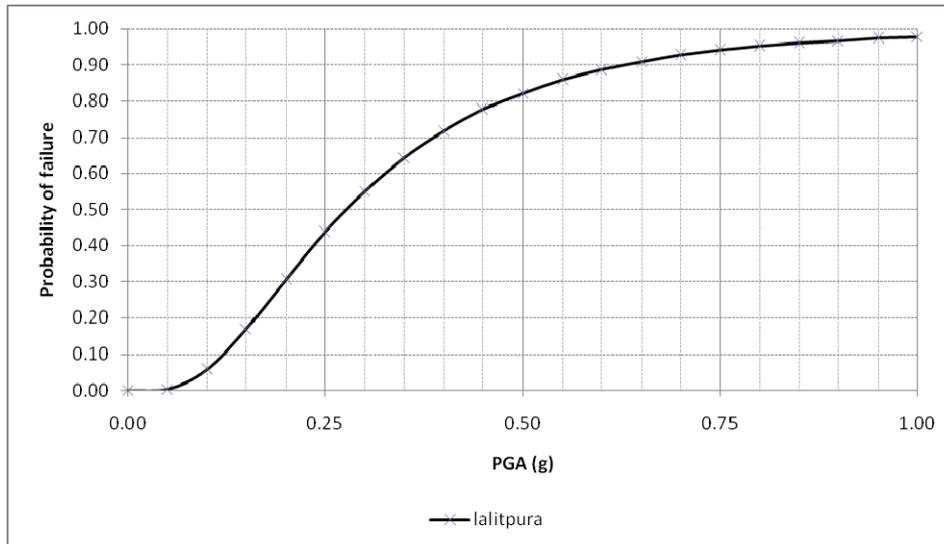
Fig. 3-3.16 Fragility curves for building C22 (CB6)

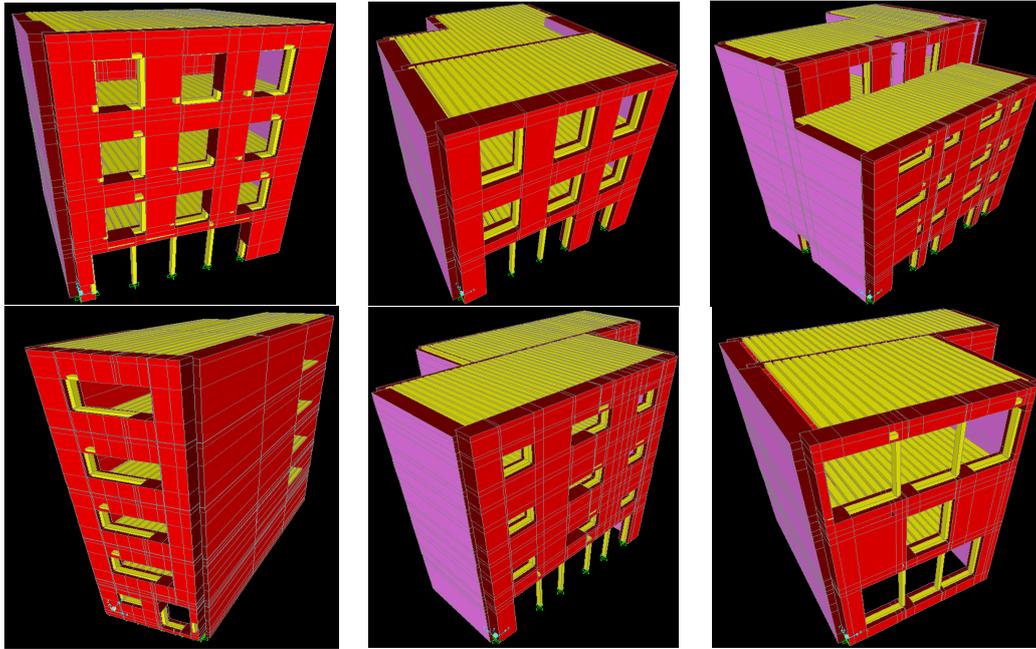
Fig. 3-3.17 FEM models of brick masonry building

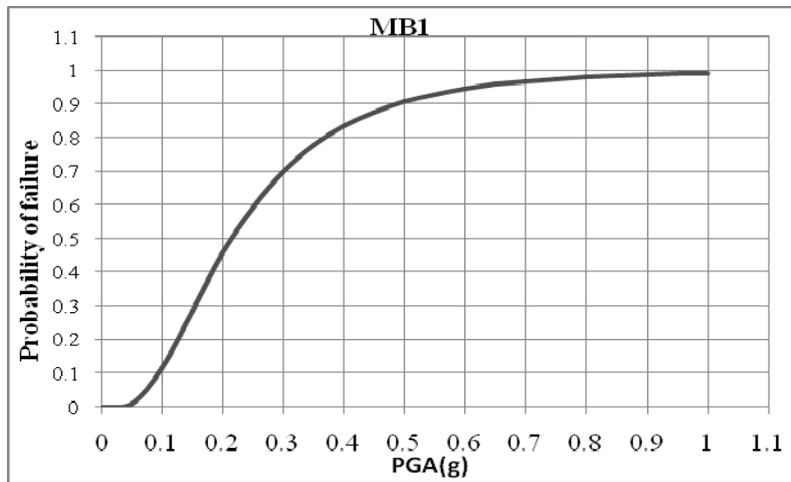
Fig. 3-3.18 Fragility curve for MB1

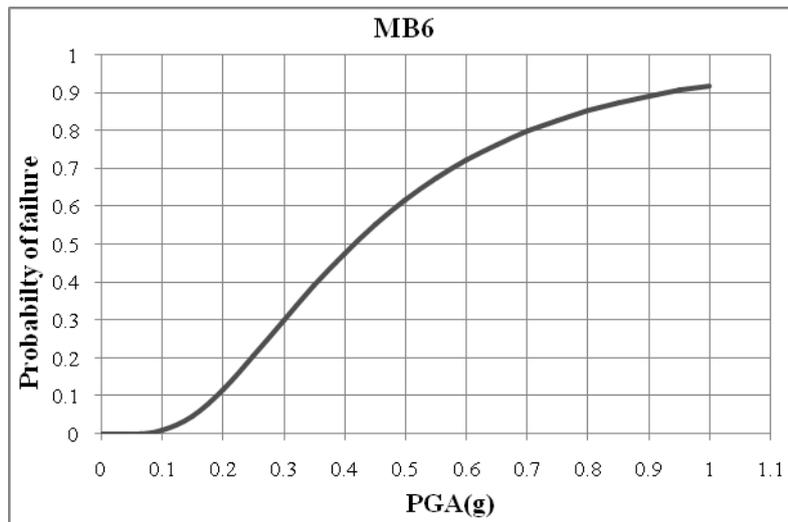
Fig. 3-3.23 Fragility curve for MB6
