Disaster Risk Management for the Historic City of Patan, Nepal

Final Report of the Kathmandu Research Project

**Research Center for Disaster Mitigation of Urban Cultural Heritage,
Ritsumeikan University, Kyoto, Japan**

Institute of Engineering, Tribhuvan University, Kathmandu, Nepal

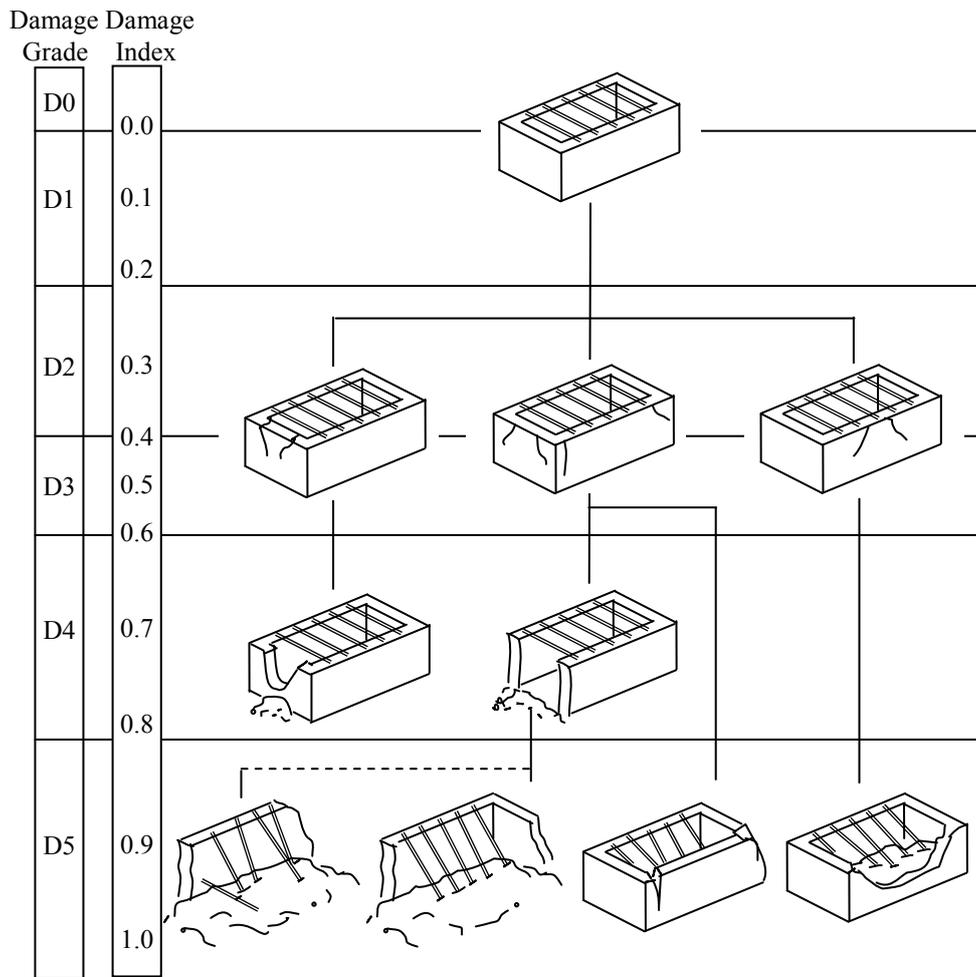
Fig.9 Damage pattern and its relevant damage index ^{2),3)}

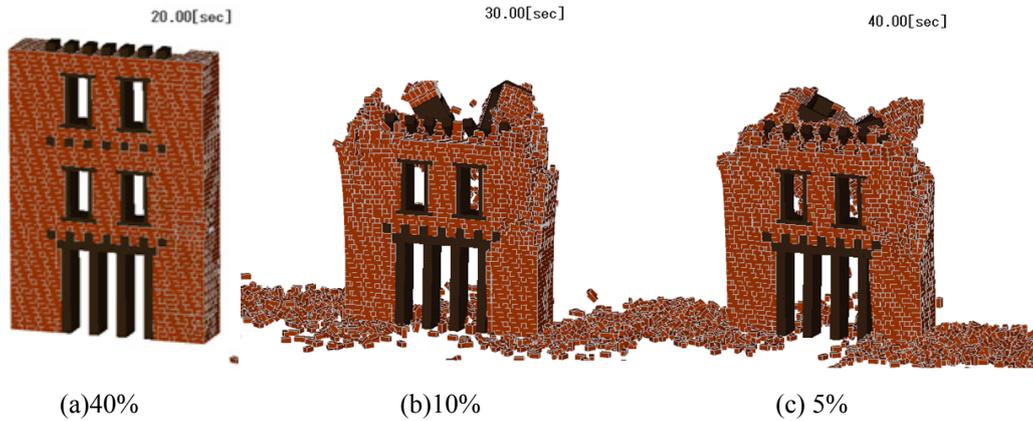
Fig. 10 Seismic behavior of 3-story masonry building

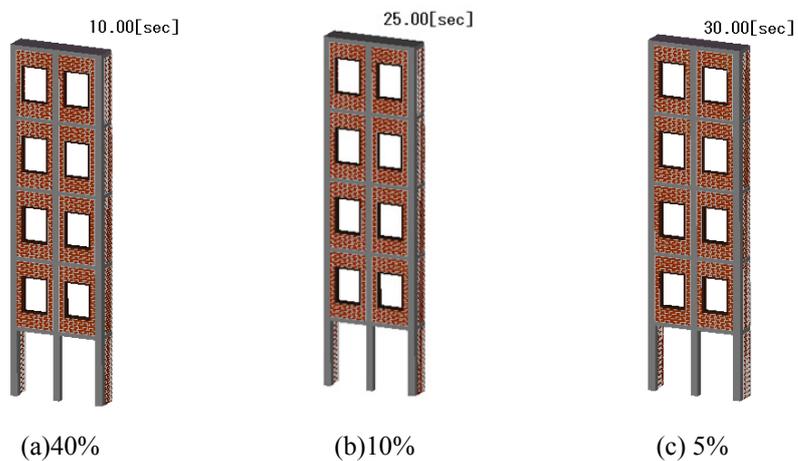
Fig. 15 Seismic behavior of 5-story confined masonry building

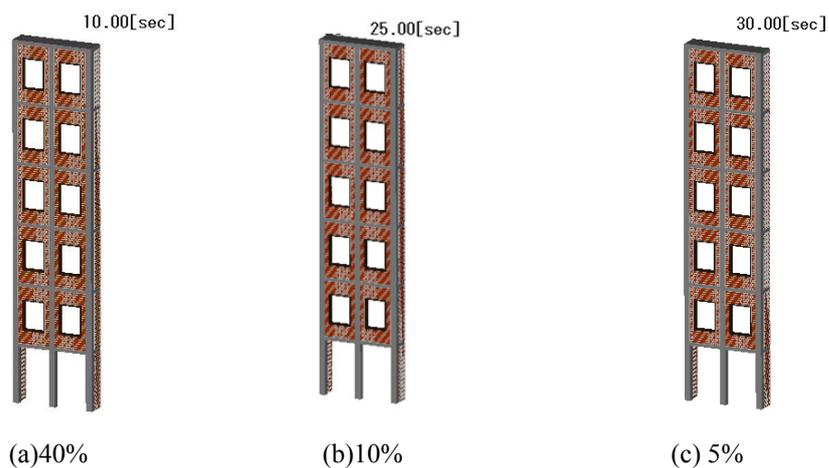
Fig. 16 Seismic behavior of 6-story confined masonry building

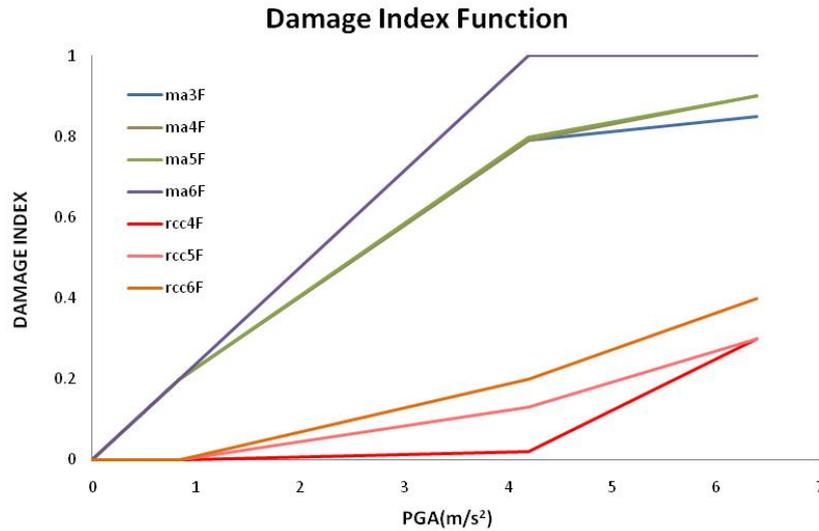
Fig. 18 Damage index function

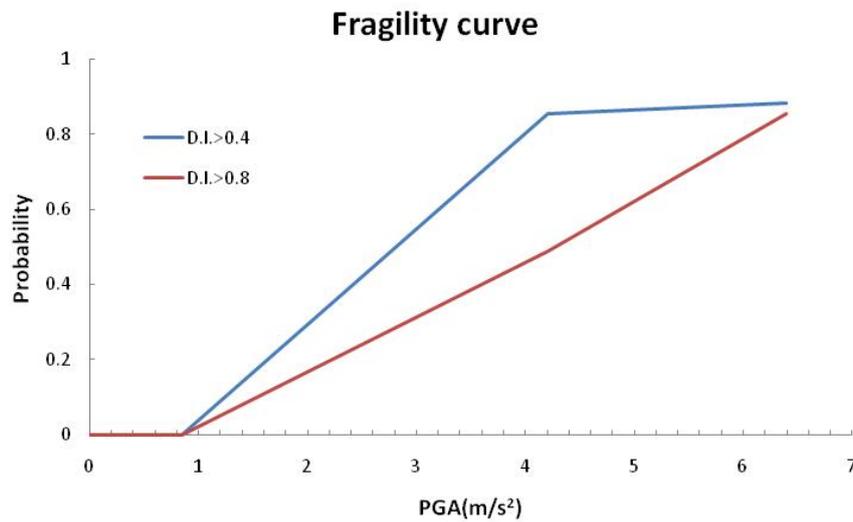
Fig.19 Fragility curve

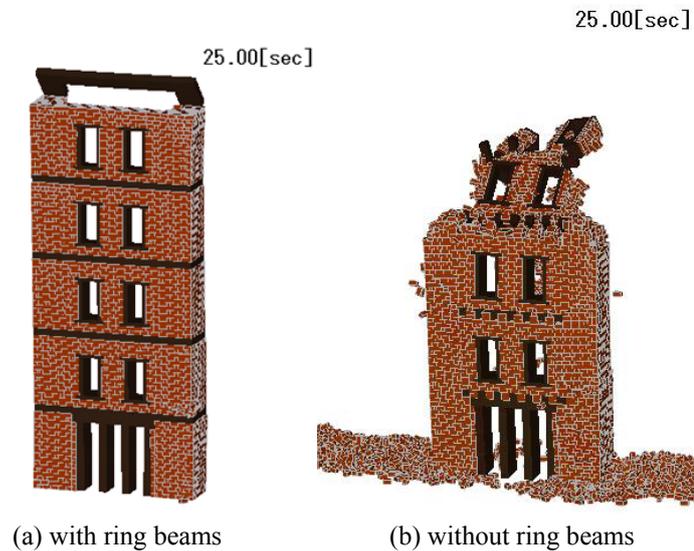
Fig.20 Effect of introducing ring beams to 5-story masonry building (ground motion with occurrence probability of 10% in 50 years)

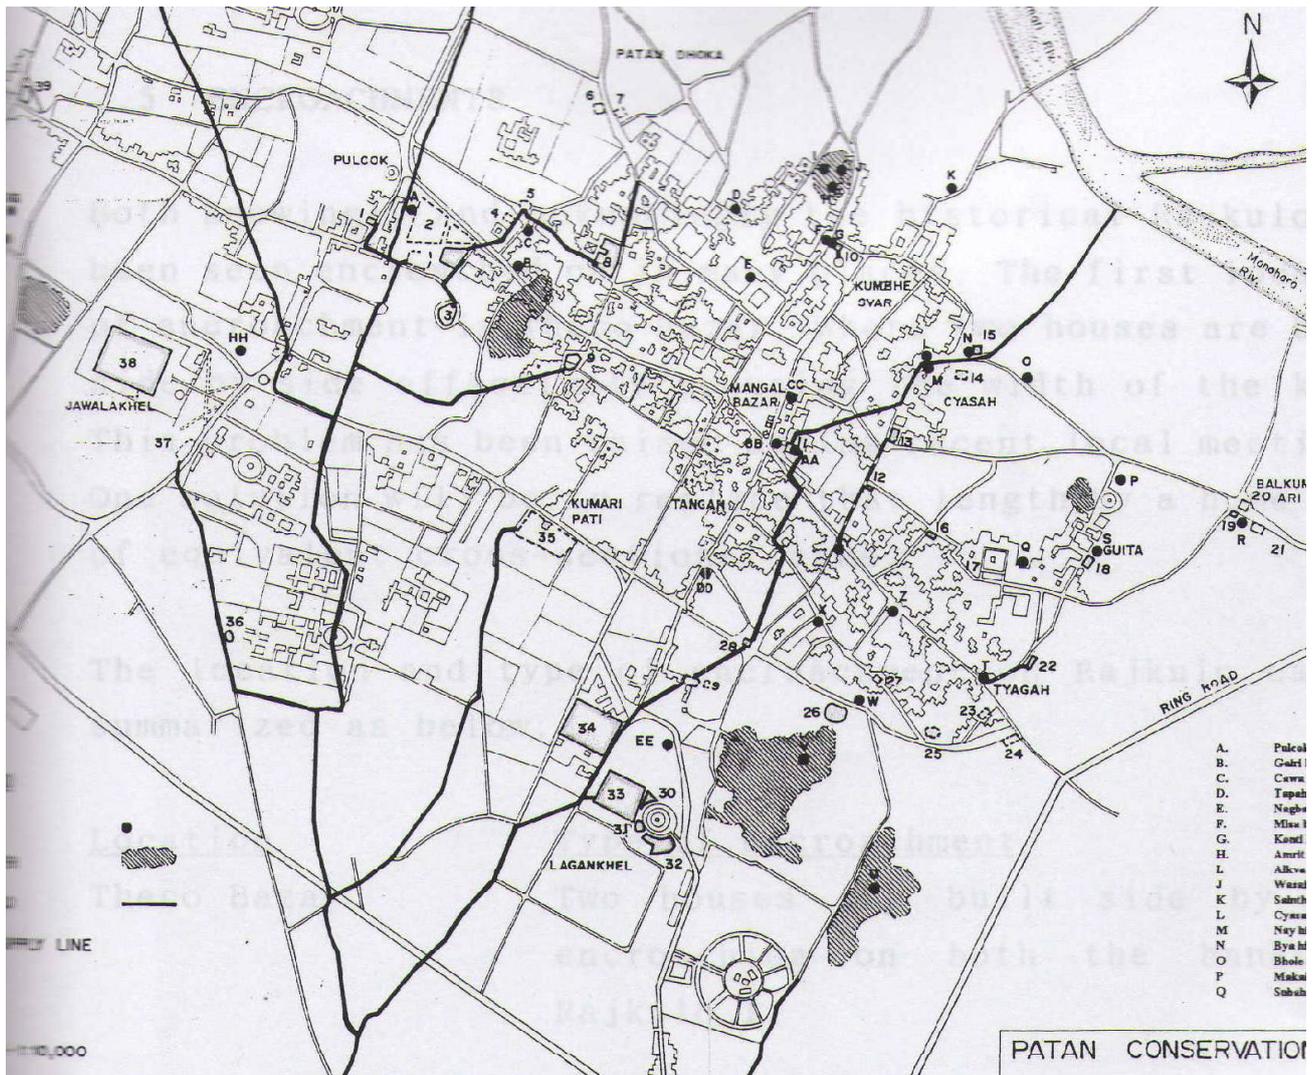
Fig. 7 Showing Linkage of Canal, Ponds, Aquifers and Hiti (Joshi, 1993)

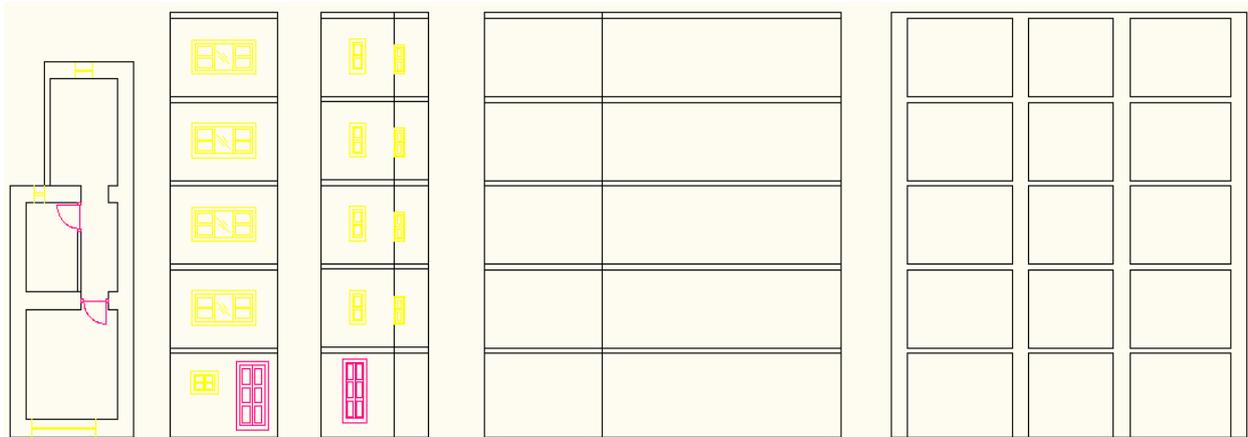
Fig. 5-1.4 Plan, Front elevation, back elevation, left side elevation and right side elevation of B47

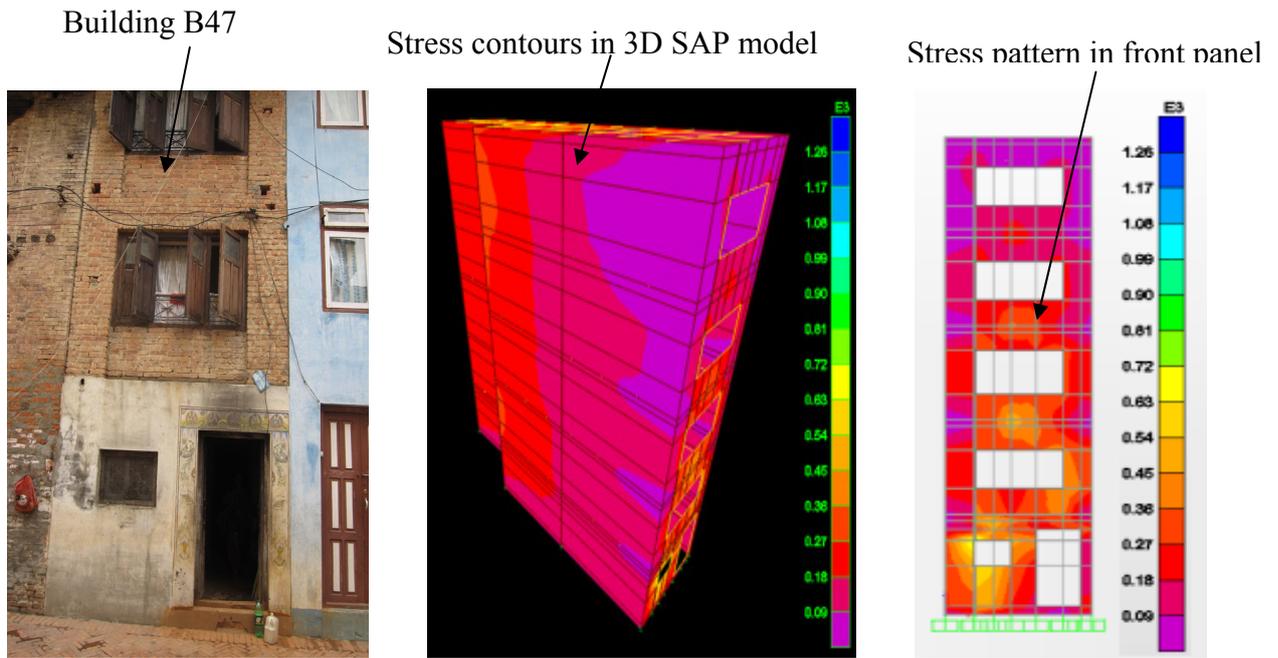
Fig. 5-1.5 Photo, stress contours and stress pattern in panel of Building B47
