Global Center of Excellence for  
Education, Research and Development  
of Strategy on Disaster Mitigation  
of Cultural Heritage and Historic Cities  
***Newsletter No.18***

## Survey of Damage Caused to Timber Buildings by May 6, 2012 Tornado

# Survey of Flood Damage to Ayutthaya Historical Park

Newsletter No.18 (July 2012)

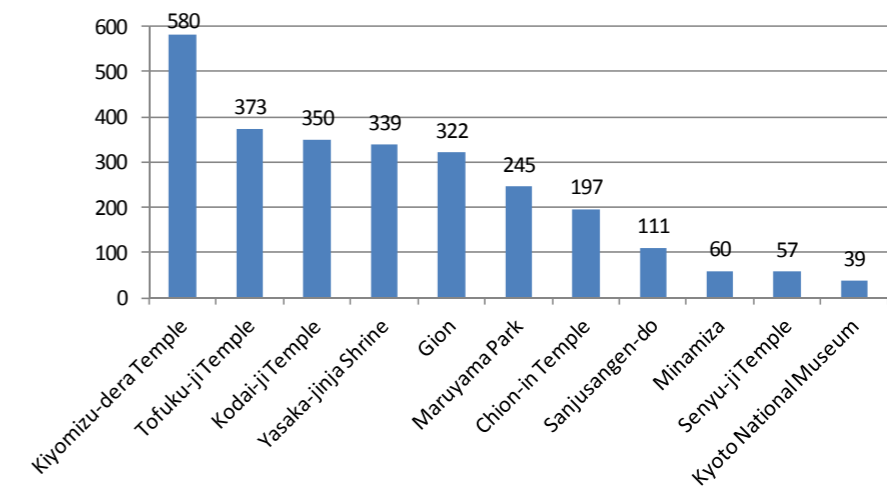
Chart 1 Number of Visitors to Major Sightseeing Spots in the Higashiyama District

Charts 1 to 3 plot the findings of a tourist questionnaire survey (931 respondents) that the authors conducted with the cooperation of tourists visiting the Higashiyama district of Kyoto in 2008. Chart 1 illustrates the number of visitors to major sightseeing spots in the Higashiyama district; Chart 2 plots samples of the hourly flow of tourists entering and leaving the Higashiyama district; and Chart 3 plots samples of the hourly change in the local Higashiyama tourist population based on the data in the first two charts. Analyzing patterns of tourist flow in this detail allows us to better understand when, where, and how many tourists are visiting. Additionally, it facilitates study and preparation for the location of evacuation centers and the design of escape routes based on these patterns of movement or behavior that will ensure tourists are better able to escape to safe areas without losing their way.

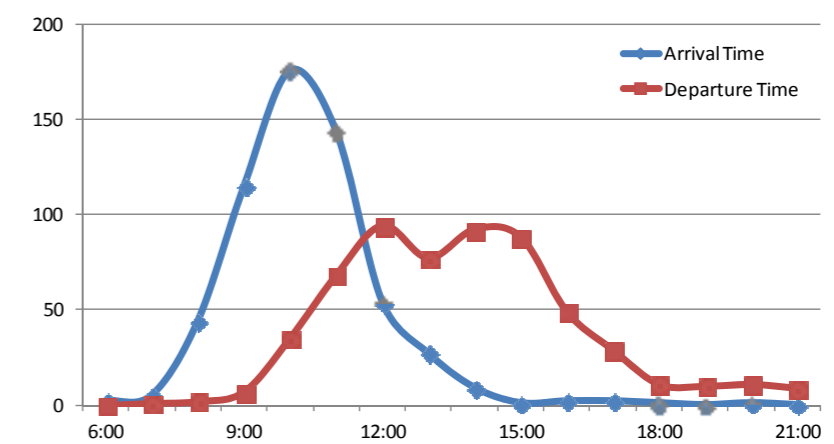
Chart 2 Hourly Tourist Flow (Arrivals and Departures) in the Higashiyama District

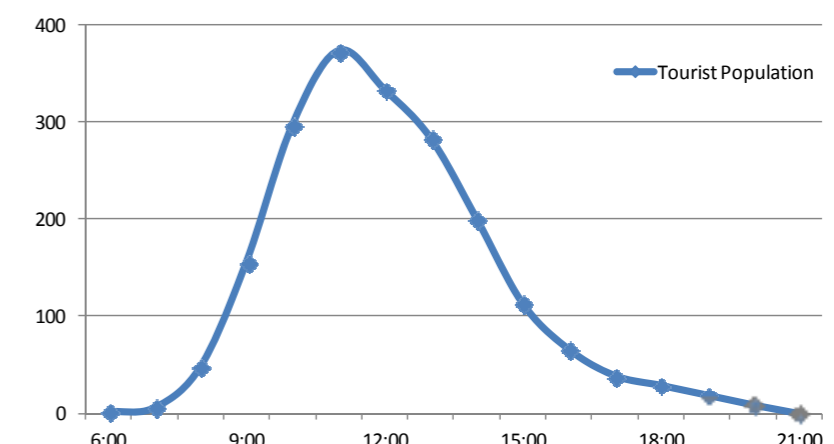
Chart 3 Hourly Change in Local Higashiyama Tourist Population

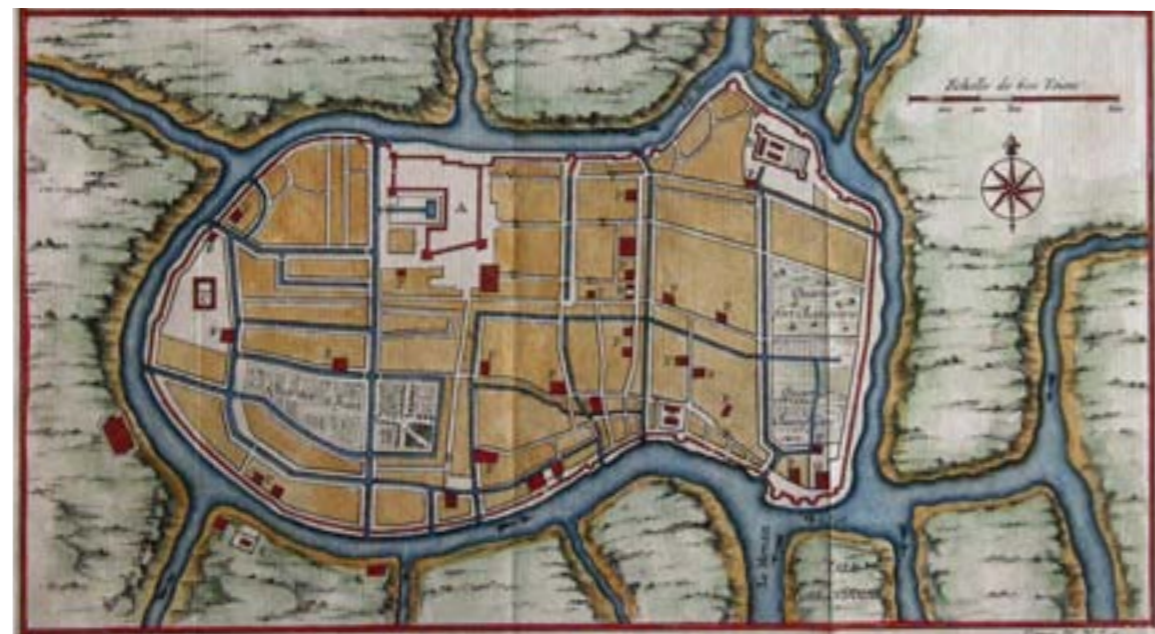
Fig. 1 The Ayutthaya ruins around 1750 A.D.

'Plan de la Ville de Siam' drawn by a French engineer, Jacques Nicolas Bellin, shows Ayutthaya in 1750. (Courtesy the Dawn Rooney Collection)

Located about 76 km north of Bangkok, the Ayutthaya Historical Park envelopes the ruins of the ancient city of Ayutthaya that were declared a UNESCO World Heritage Site in 1991. This city was built by King Uthong in 1350 A.D. on a small delta surrounded by the Chao Phraya, Lopburi, and Pa Sak Rivers. Until its destruction by the Burmese Army in 1767, it served 417 years as the capital of the Ayutthaya Dynasty and as a center of Thai politics and commerce. During this long period of dynastic rule, many Buddhist temples and statues were built. The ruins include temples that even today are reminiscent of the prosperity that once reigned in Ayutthaya's heyday (Fig. 1).

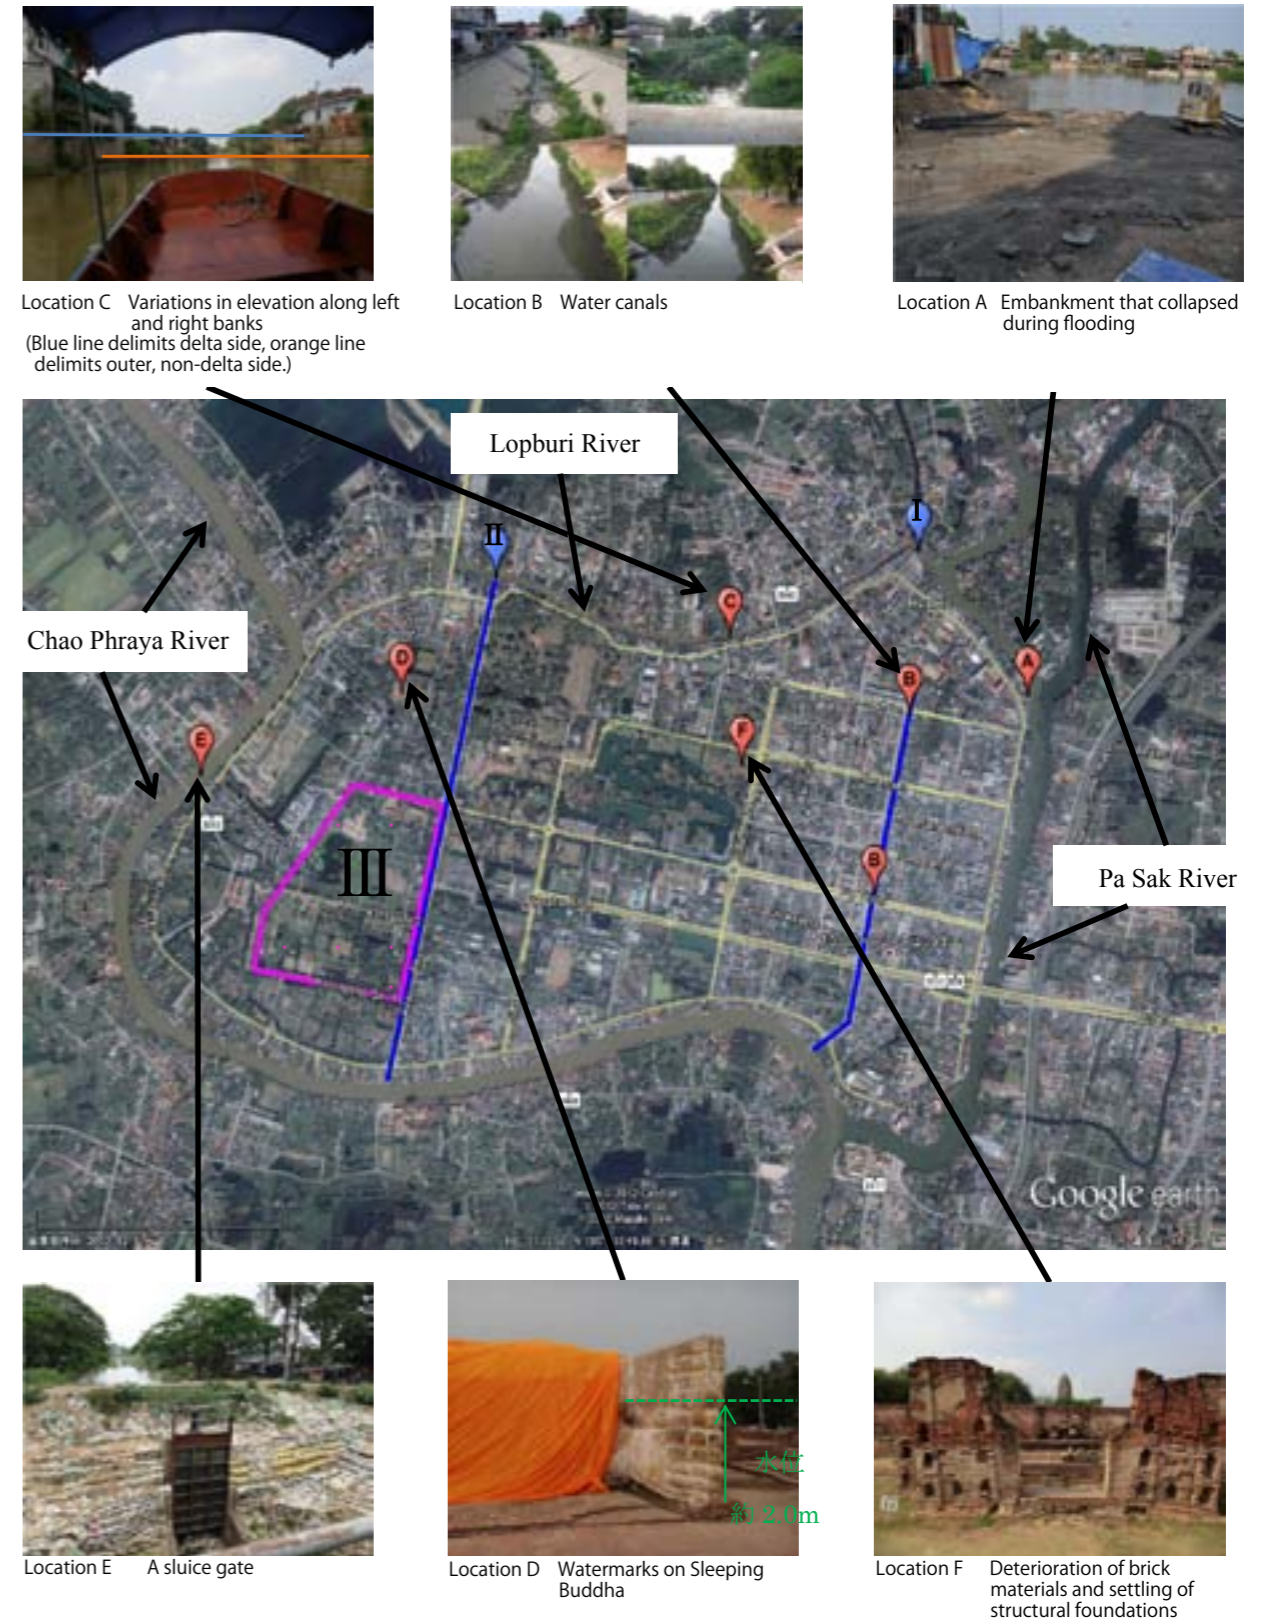
Location C Variations in elevation along left and right banks (Blue line delimits delta side, orange line delimits outer, non-delta side.)

Location B Water canals

Location A Embankment that collapsed during flooding

Exhaustive steps had been taken to protect the Ayutthaya ruins from flooding. Local residents had built sandbag embankments while Ayutthaya city employees had formed a full-time 24-hour monitoring framework. However, around 10 p.m. on the evening of October 7, an embankment or sluice gate on the northeastern bank of the city's delta zone (near the confluence point of the Pa Sak and Lopburi Rivers) was undercut by water erosion, allowing a massive influx of floodwaters into the delta (Fig 2, Location A). These floodwaters reached from 0.5 to 2.0 meters in depth and continued to inundate the city delta for over a month. Additionally, a zone of public parklands along the southwestern perimeter -- one of the lowest areas within this entire district -- remained flooded the longest (Fig. 2, Location III).

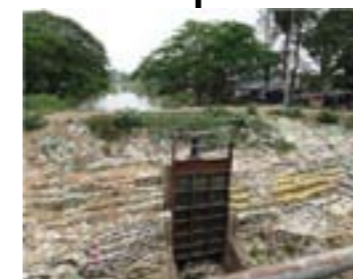
Location E A sluice gate

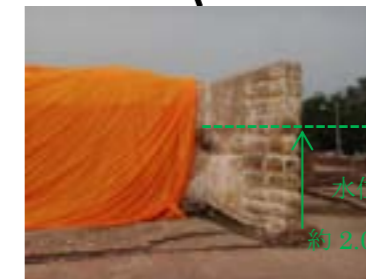
Location D Watermarks on Sleeping Buddha

The ancient city's Wat Lokaya Sutharam temple (Fig.2, Location D) houses a large statue of the sleeping Buddha, on which traces of the water line from the most recent flooding clearly remain. Like the Wat Mahathat temple (Fig.2 Location F), it contains numerous structures built from brick. This brick material is referred to as "field brick" and is produced through firing at relatively low temperatures. The surface features of field brick that has been exposed to extensive weathering can be literally rubbed out with one's fingertips. Some of the brick used in structures at the ruins showed signs of whitening but these were actually marks indicating the depth of the water line from the most recent flood and are thought to be discoloration caused at that time by the leaching of dye or pigment from the brick material.

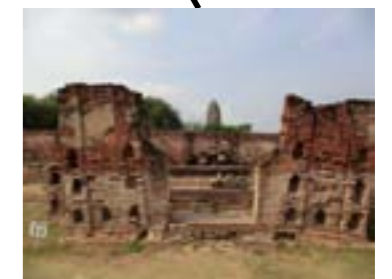
Location F Deterioration of brick materials and settling of structural foundations

The deterioration and erosion of the brick material as a result of long-term inundation during the most recent flood presents a serious problem. Another extremely serious problem is that like the Leaning Tower of Pisa, structures at many locations throughout the ruins have begun leaning due to the irregular settlement of soil sediments under their foundations. Several centuries have intervened since the buildings of the ancient city of Ayutthaya were constructed. In view of the likelihood that the soil settlement process is still under way, it is entirely plausible that some of these structures could eventually collapse if left unattended. This is an issue demanding an urgent response.
