# C 部会

## 歴史文化都市の防災デザイン研究部会

## 法隆寺金堂壁体の構法の復元——壁画の今後の保存と活用に向けて

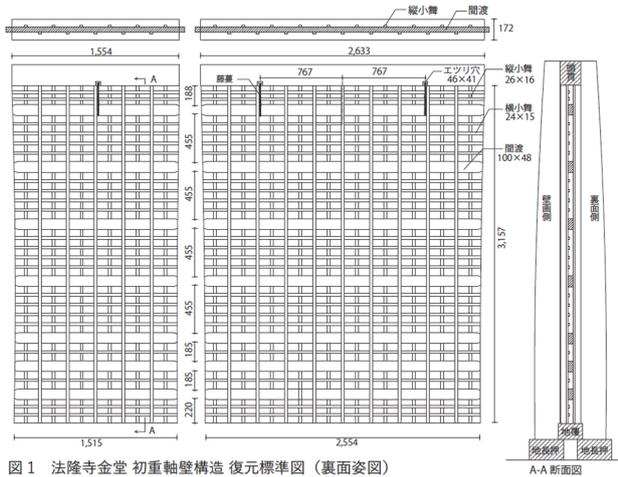
図1 法隆寺金堂 初重軸壁構造 復元標準図 (裏面姿図)  
※各部分の寸法は各面各部寸法の平均値である(表1参照)。  
※壁間渡が柱に横絡めされるところもある。

- 壁間渡は壁総高をほぼ6等分した芯に配され、一番下とその上の間には1本多く配される。(全12壁)
- 壁間渡の楔締めは部分的
- 横小舞は壁間渡間に4本、壁体下部の間渡間が狭くなる二間は1本を入れるのが標準
- 縦小舞は壁間渡に対して前後千鳥に配置される。
- 縦小舞の本数は、大壁19本、小壁11本が標準的
- 小舞は藤蔓で絡げられる

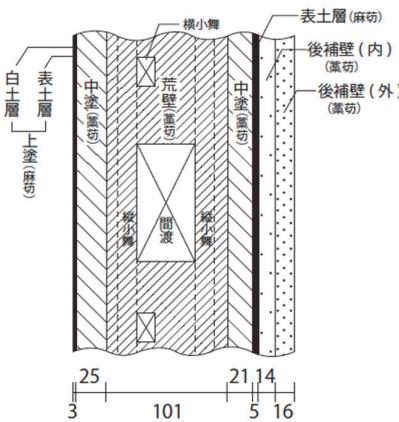
図2 法隆寺金堂壁土組成図 (昭和修理直前)

※各層厚みは各面各部寸法の平均値である(表2参照)。

- ・昭和修理直前における金堂初重軸部の土壁の層構成は、
- ・室内側(壁画側)から、
- 白土層(苧:麻)—表土層3mm(苧:麻)—中塗25mm(苧:藁)
- 荒壁101mm(苧:藁)—中塗21mm(苧:藁)—表土層5mm(苧:麻)—後補壁層30mm(後補壁は2層)
- ※後補壁ができた年代は不明(仕上げは漆喰)
- ※各層の厚みは6サンプルの平均値(壁により寸法のばらつきあり)

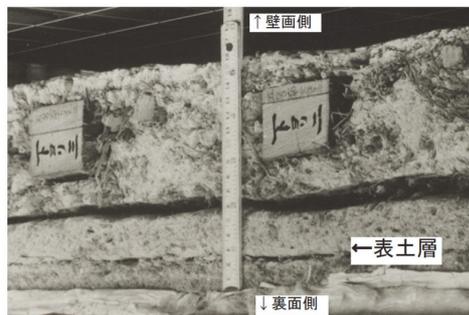
図6 五号壁断面詳細写真(尺度付)

寸法が分かる壁体サンプルとして3面・6ヶ所を収集できる(表2)

- ・裏面の壁内20mm程度の位置に、「表土層」が確認できる。
- ・当初、壁間渡は、およそ壁芯に配置されていた → 構法的に合理的
- 壁画下地=白土層のすぐ下には「表土層」があると考えられる

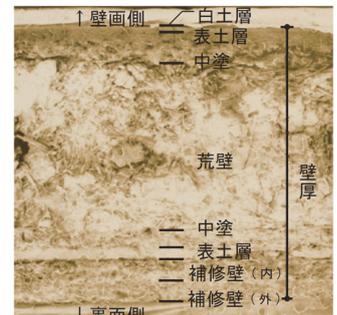
図7 一号壁断面詳細写真

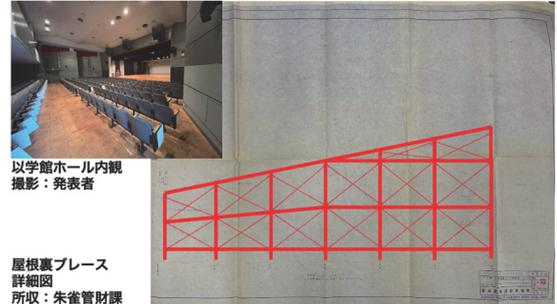
以学館階段教室の構造図面

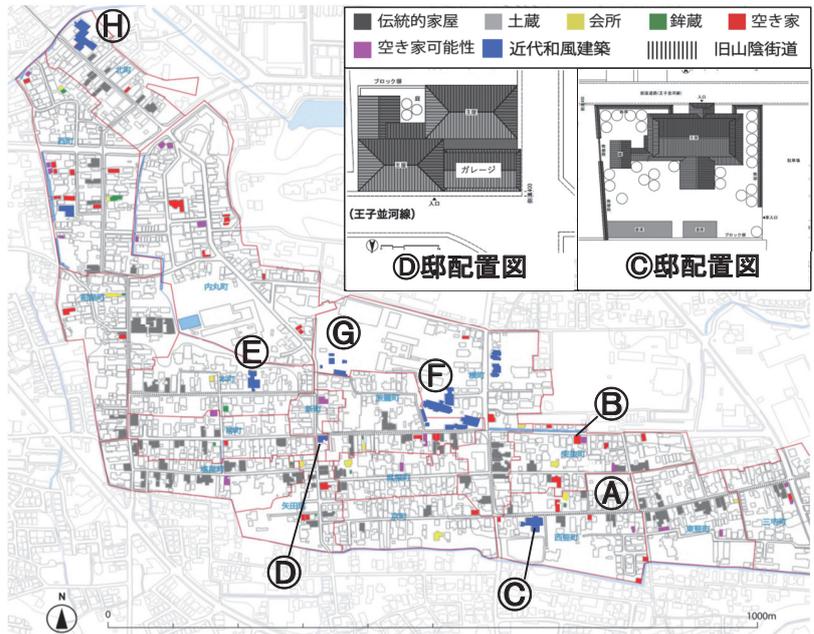
空き家と近代和風建築の分布図

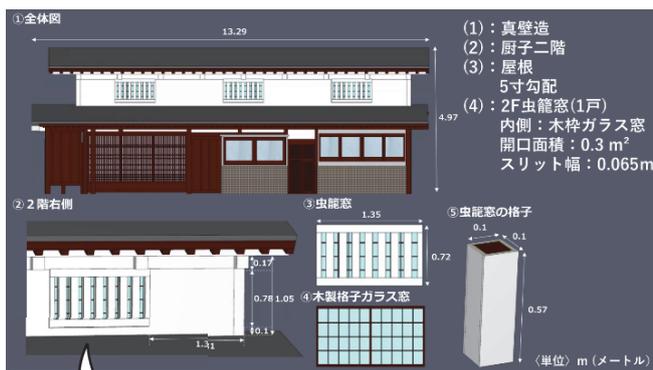
図1. 類焼する町家の概要

- ・ 虫籠窓が存在する場合には、隣棟する町家からの類焼、対面する町家からの類焼とともに、一定の類焼遅延効果があることが明らかになった。
- ・ 虫籠窓のスリット幅に関して、本研究で検証した6.5cm～13cmの範囲においては、各スリット幅を狭める方が、類焼遅延効果が期待できる。
- ・ ガラス窓枠の部材に関して、木枠は発火するまではアルミ枠よりも屋内の温度上昇を防ぐ。

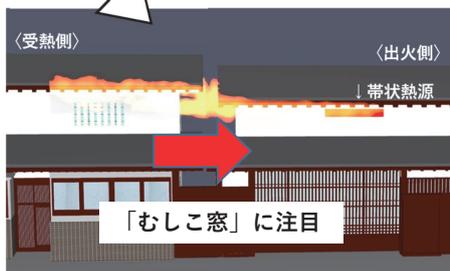
図2. 開口噴出火災のモデル図

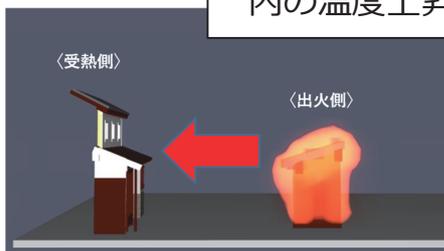
図3. 対面する町家が出火するモデル図

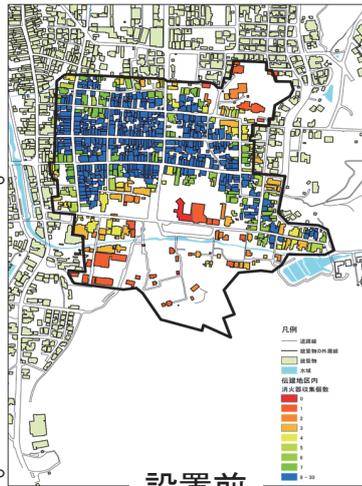
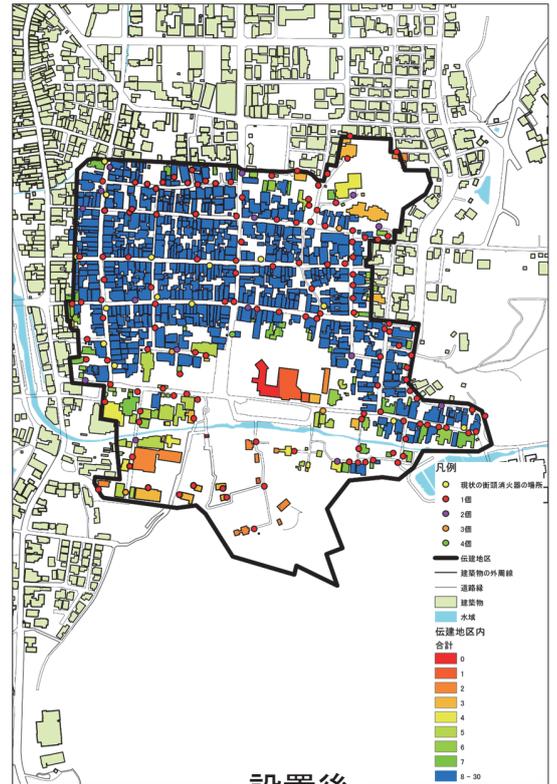
消火器収集率に関して：  
初期消火の定義を用いて建物の重心30m以内に消火器を8本集めることができたなら初期消火完了としたのでその時点で消火器収集率を100%とする

※GISを用いて定量的な評価を行った

地区内に街頭消火器を設置する予定がある出石地区を対象にして効率的に地区内の消火器収集本数が8本以上になるように設置することができた。

しかし、内町・魚屋の一部エリアにおいては今回の設置手順では消火器収集本数を8本以上にすることはできなかった。これは、建物間隔が広いことや観光客があまり立ち寄らないことが要因と思われる。

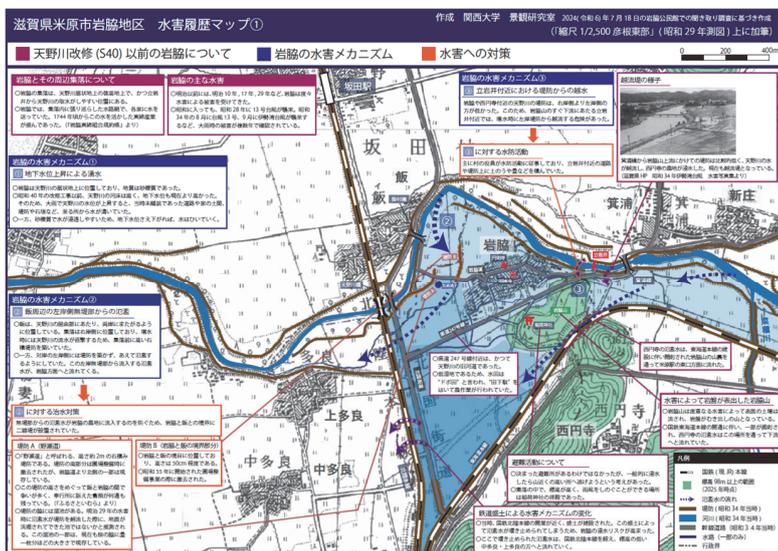
昭和40年頃までの岩脇周辺の  
水害メカニズム解説マップ  
(不連続堤による氾濫許容型治水)

昭和28年9月25日台風13号  
昭和34年9月26日・27日台風15号(伊勢湾台風)の  
天野川増水・氾濫による被害を把握

(地下水位上昇による内水氾濫、不連続堤開口部からの外水氾濫などの水害メカニズム解明)

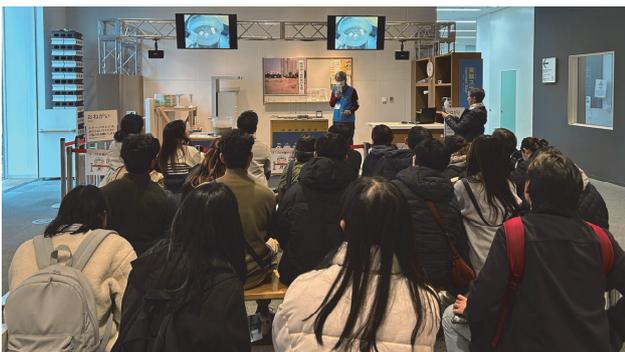
図1 耐震建物と耐震補強技術のデモンストレーション

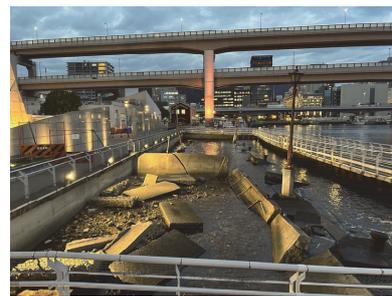
図2 被災した旧波止場跡

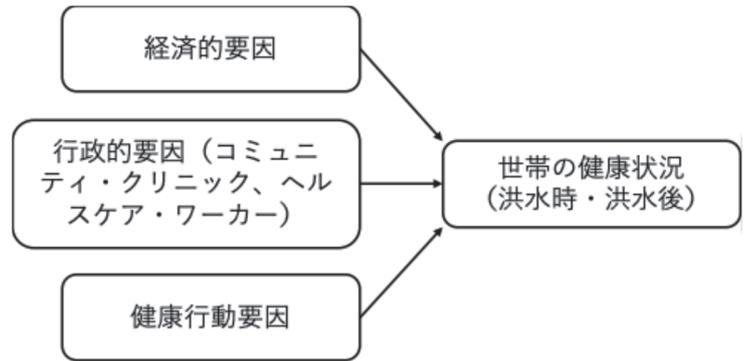
図2：本研究の仮説モデル

まず、地域知と対象地域の実情に沿って、下記モデルを開発した。人口統計的要因（経済的要因）だけでなく、行政関与という面での行政的要因や世帯の健康行動要因の影響を明らかにすることで、地域知の普及程度と、地域知を有する住民の特徴などを抽出する。
